# **PROPERTY INSPECTION REPORT FOR 2004 Marengo Dr**

**Bama Home Inspections llc**

**2004 Marengo Dr**

**Date of Inspection: 2/19/2025**

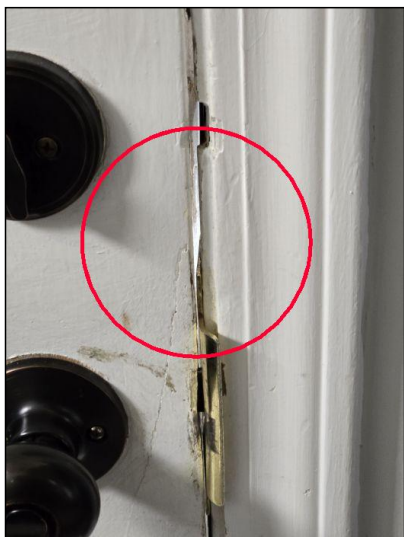
All exterior doors needs the seals replaced.

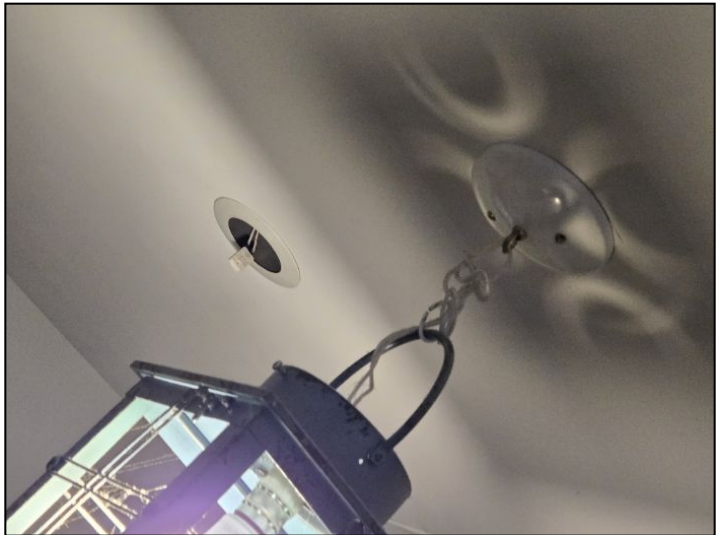
Light bulbs missing in dinning room.

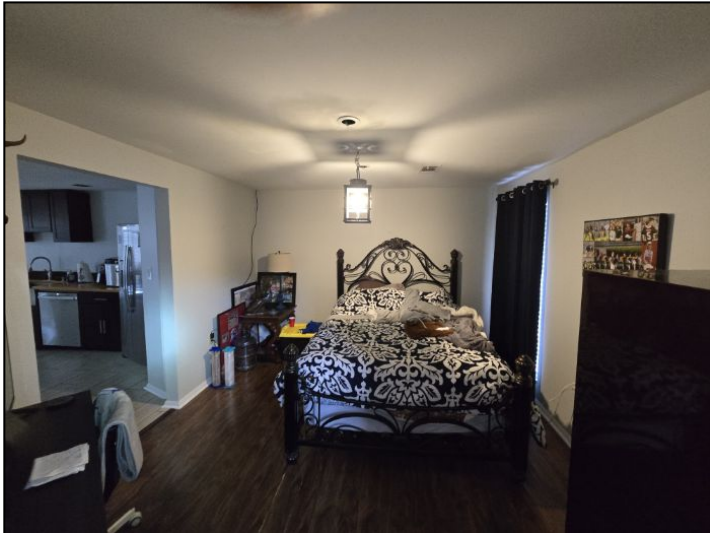
Light bulbs missing in dinning room.

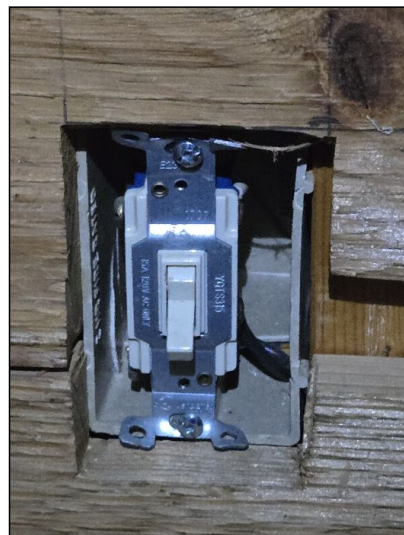
All electrical connections should be located in a junction box.

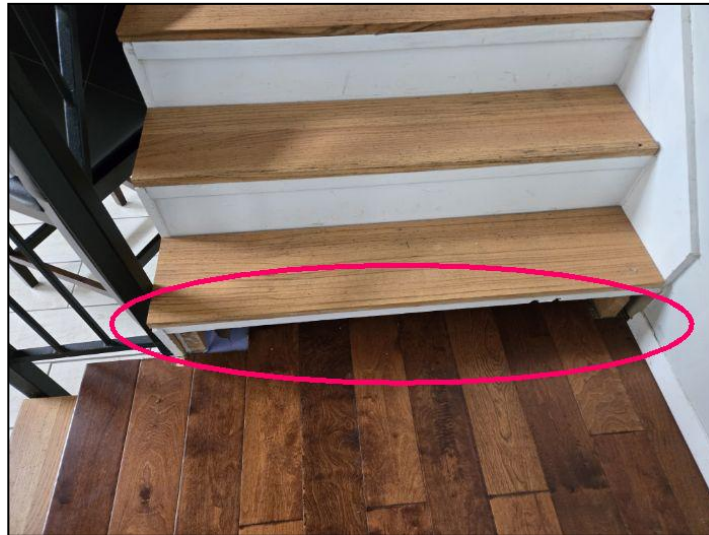
Missing rising on main staircase.

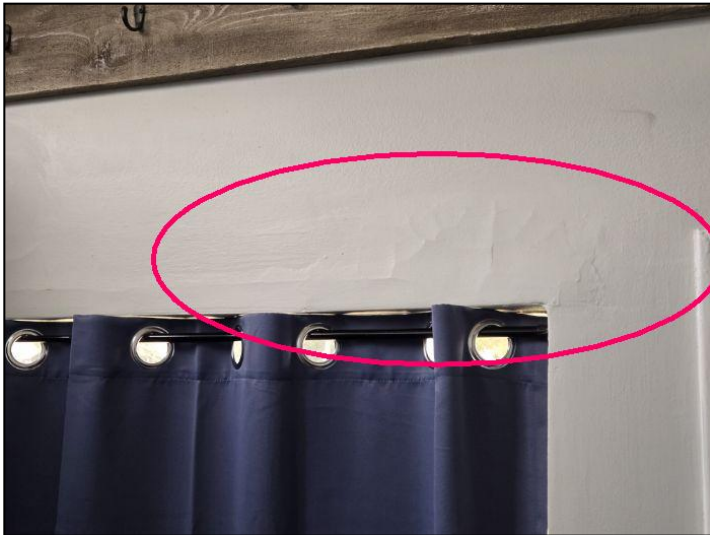
Paint bubble due to possible water intrusion.

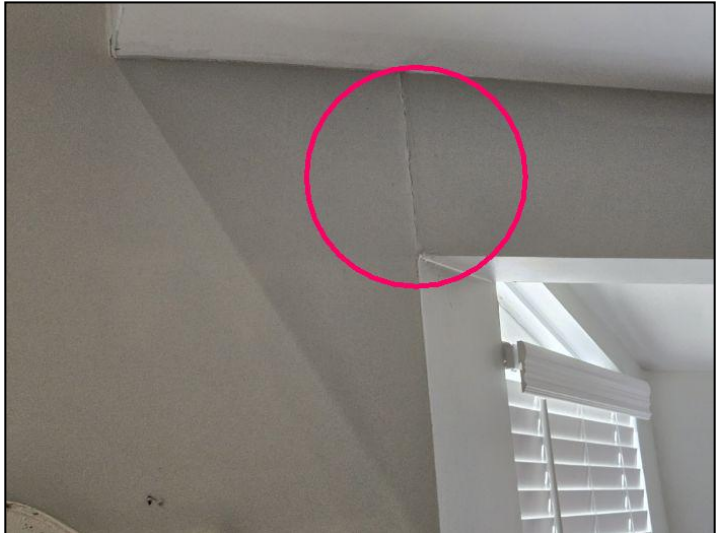
Small cracking. Possibly from settlement of house.

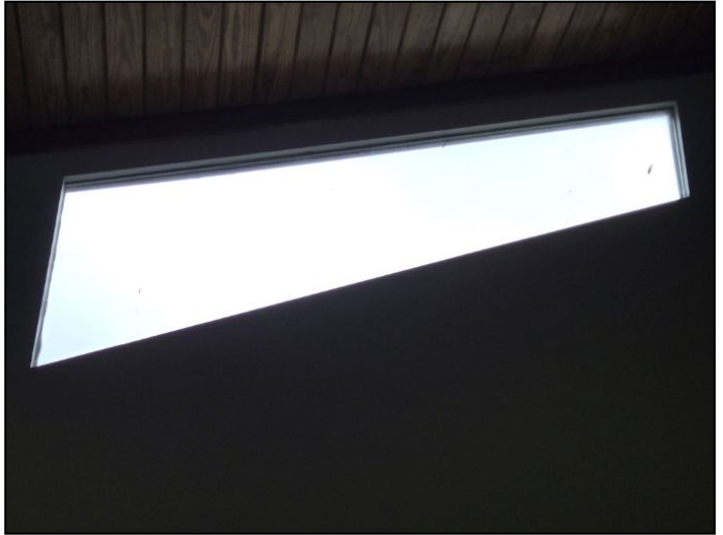
Windows would not open during the inspection.

In the inspectors opinion the windows/frames are near the end of their useful life.

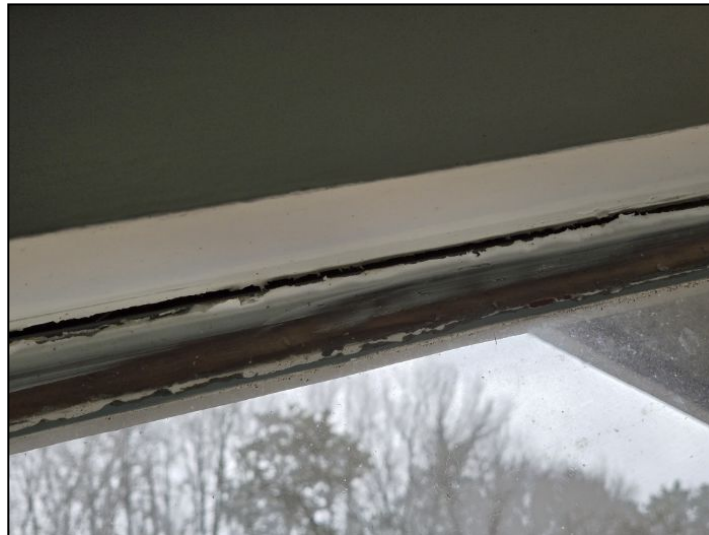
Deterioration noted due to contact with moisture, repairs needed.

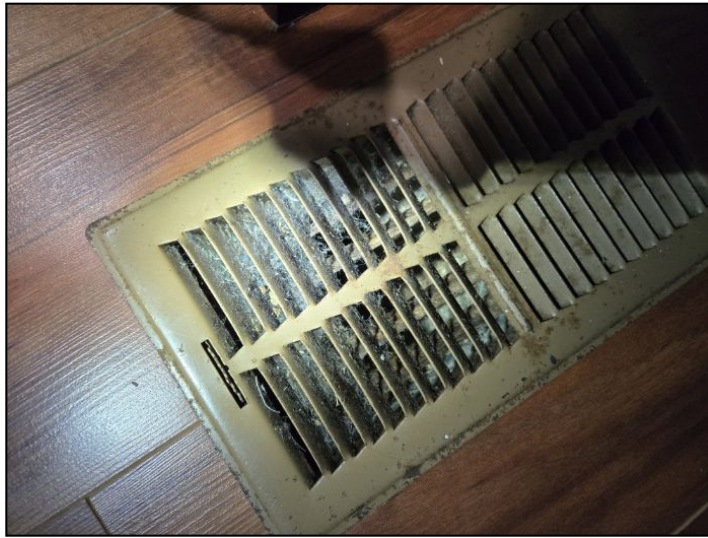
All vents need to be professionally cleaned.

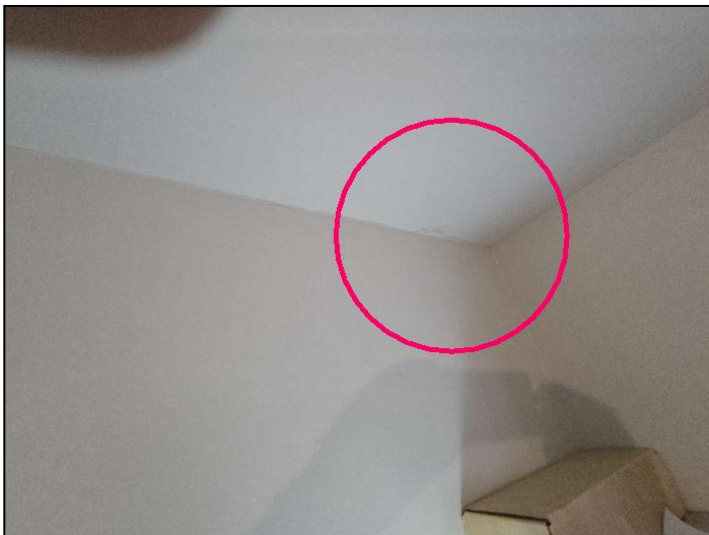
Possible water damage.

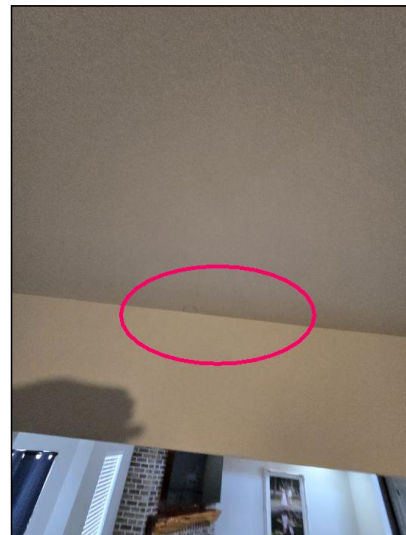
Possible water damage.

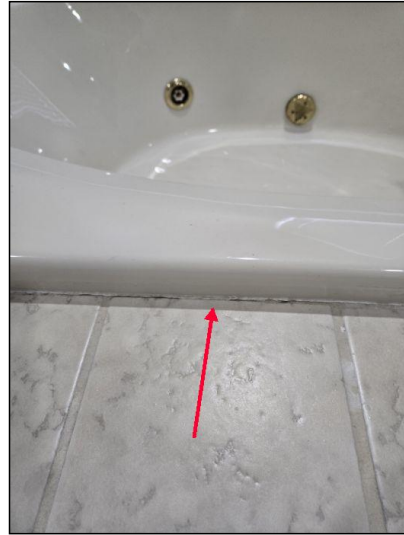
Caulking needs to be redone

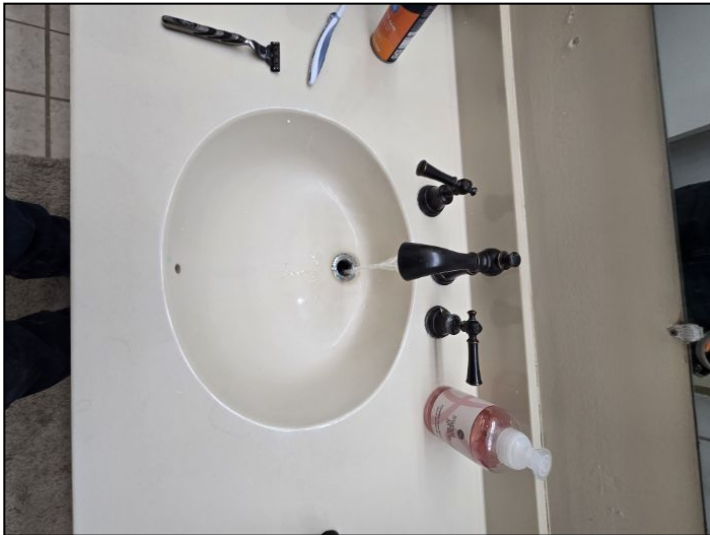
No stop in sink. Hot water not working.

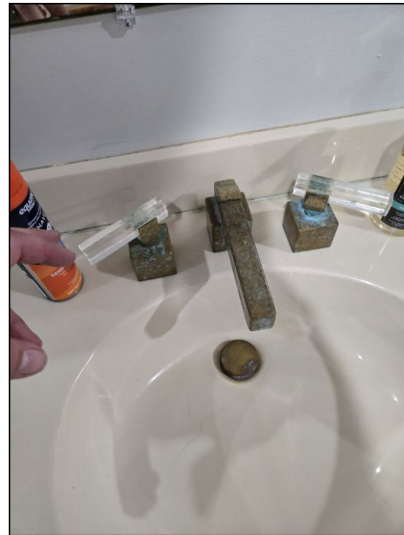
Faucet corroding in master bathroom sinks.

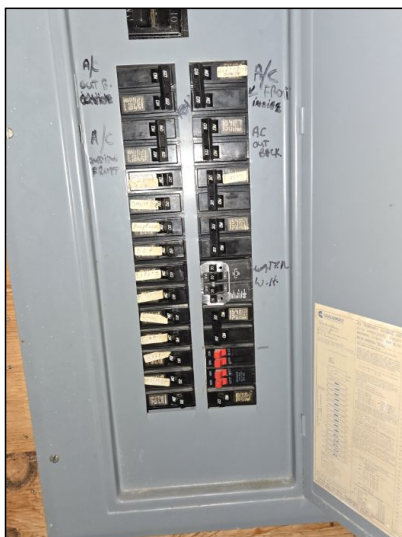
Electrical panel not properly labeled.

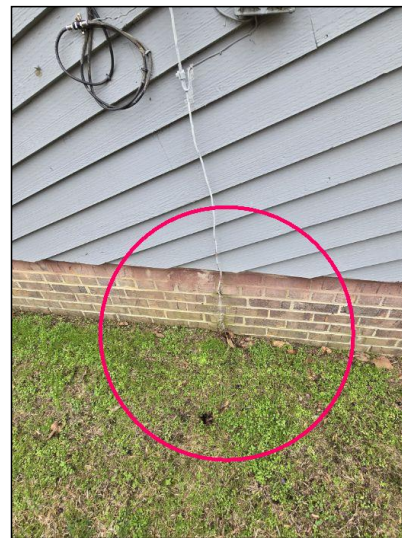
No grounding rod seen.

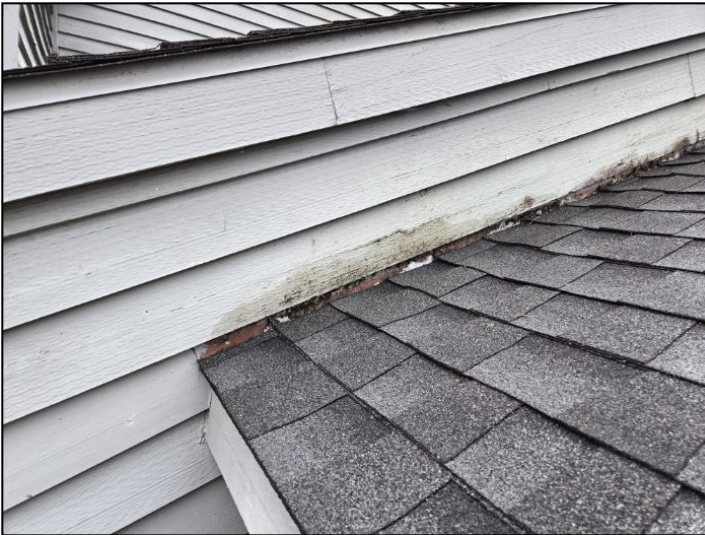
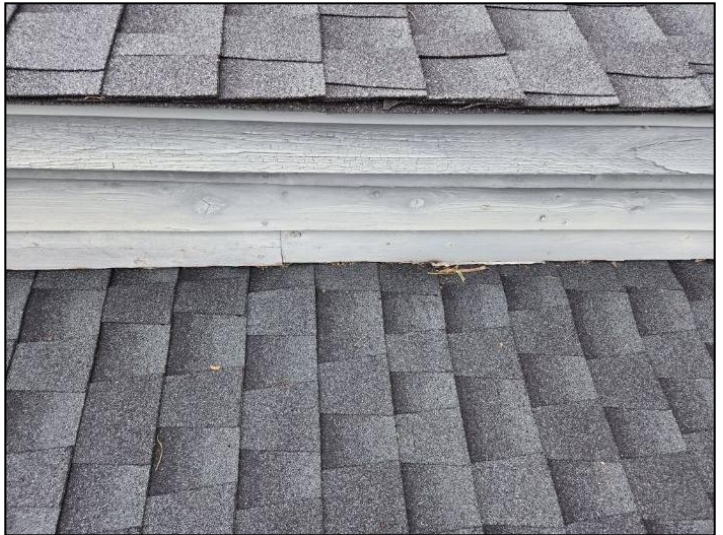
- In the inspectors opinion the flashings are near the end of their useful life due to wear.
- Recommend review by a licensed roofer for repair or replacement as necessary.
- Poor roof flashing- it appears there are no **drip edges** installed.

Recommend review by a licensed roofer for repair or replacement as necessary.

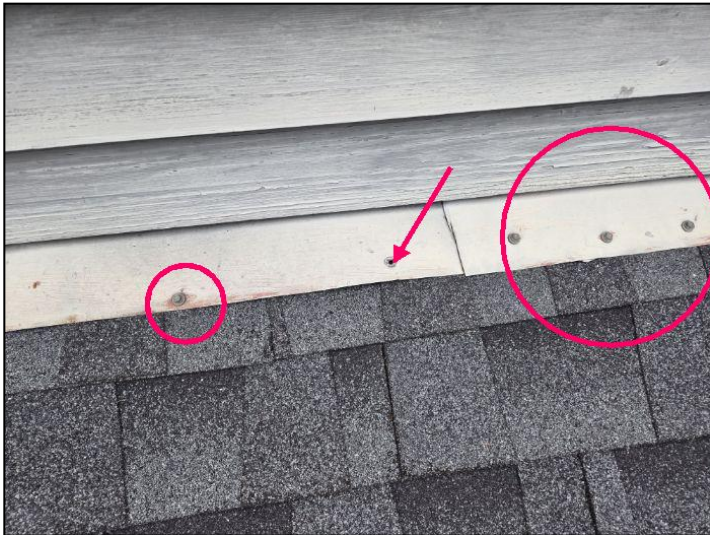
Missing screws in flashing, and screw heads should be sealed to prevent water damage.

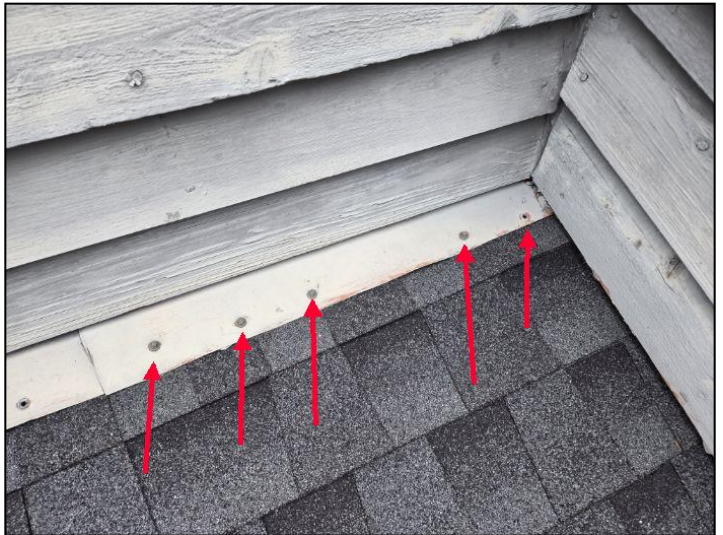
Flashing fasteners should be sealed to prevent water damage.

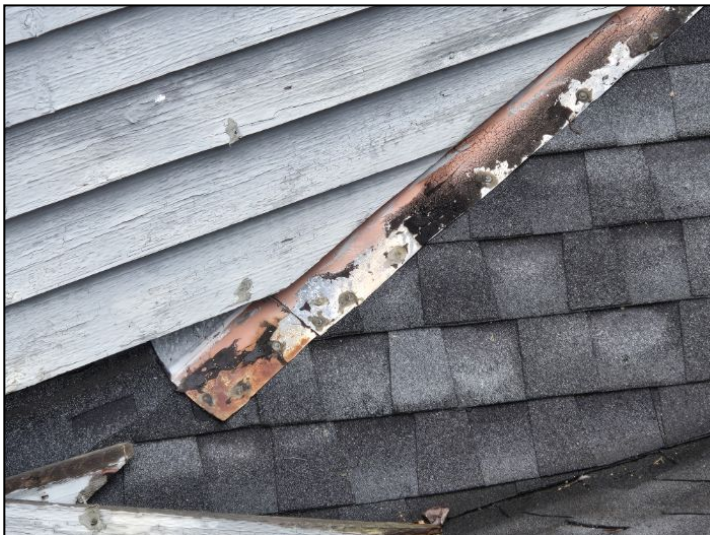
In the inspectors opinion the flashings are near the end of their useful life due to wear.

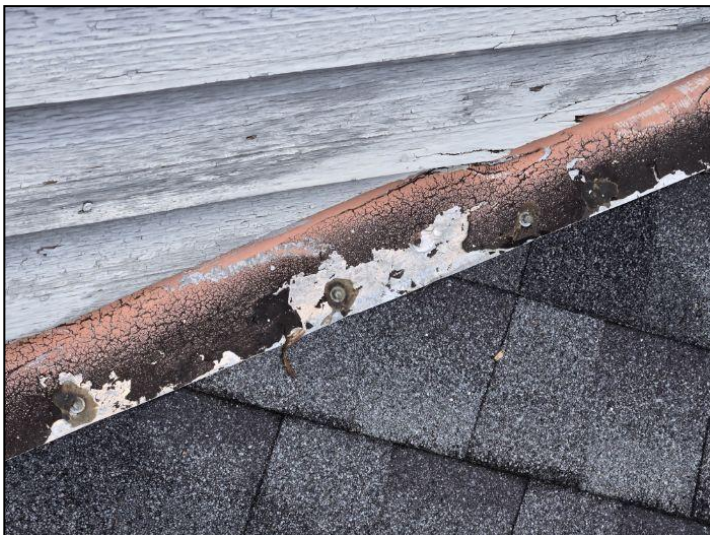
In the inspectors opinion the flashings are near the end of their useful life due to wear.

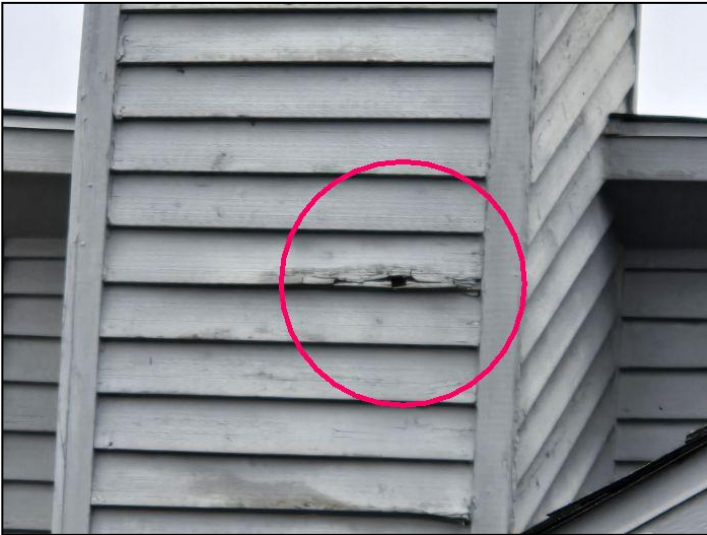
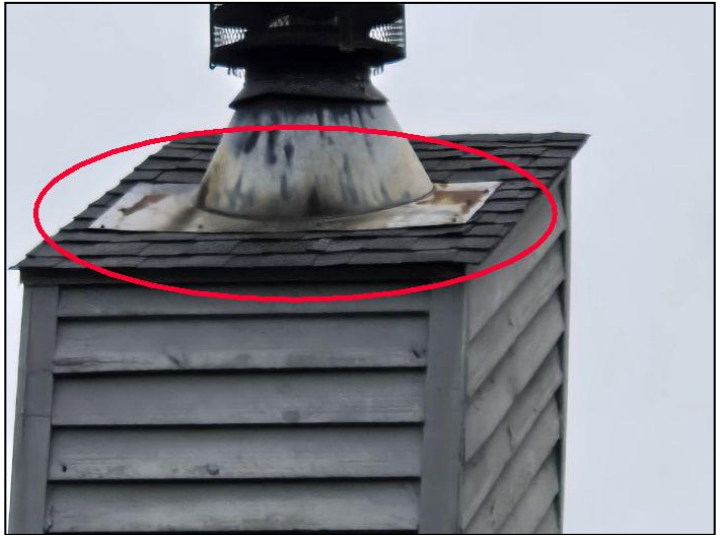
Some wood deterioration noted. Have repaired as necessary.

Chimney cap should not lay on top of roofing. Not sealed properly, and water can get into chimney from under the cap.

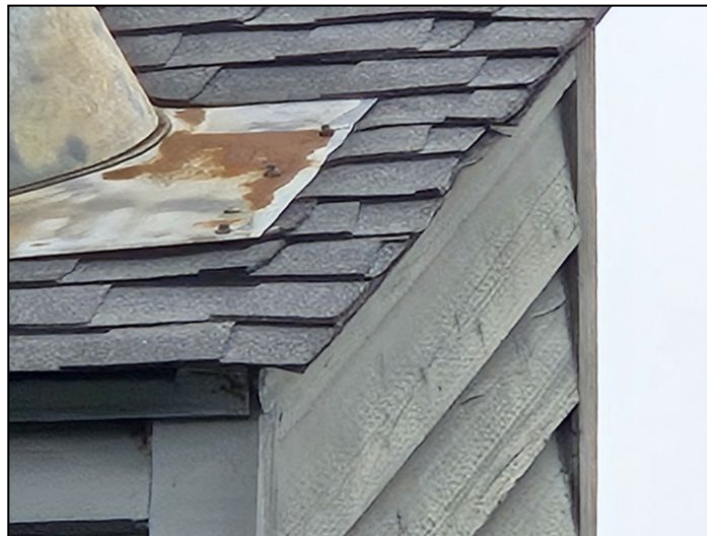
Rusting noted on chimney cap.

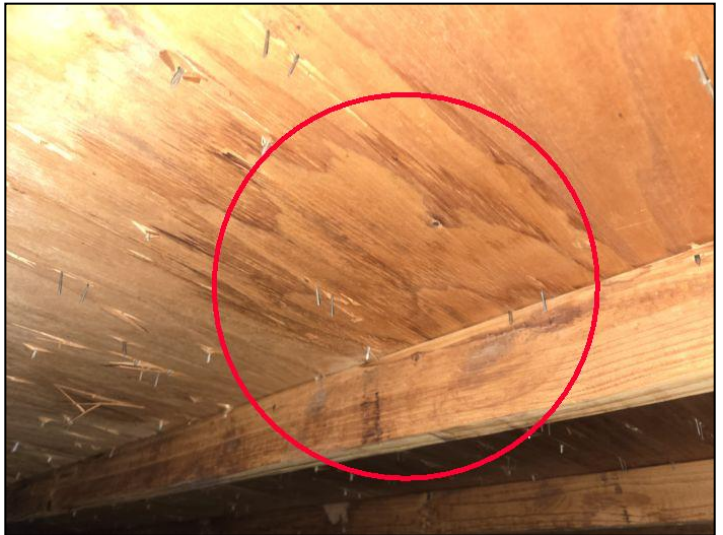
Evidence of past or present leaks, dry at time of the inspection. Monitor for leaks &/or have roofing contractor evaluate.

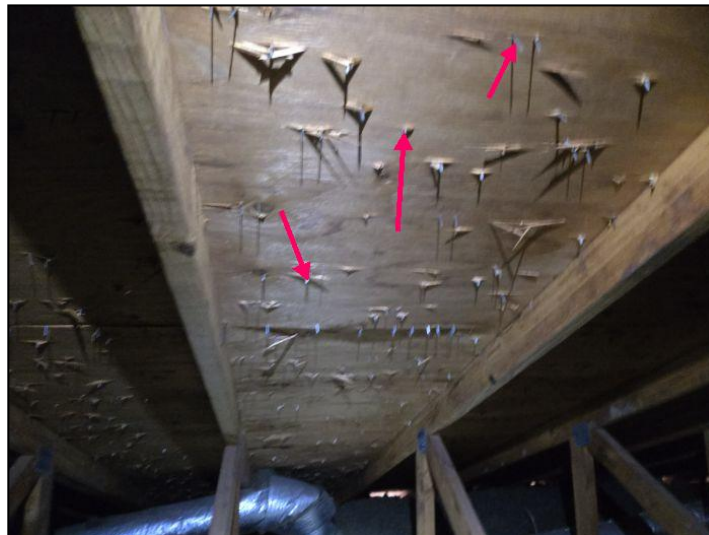
Staples seen in roof sheathing. Unknown what from.

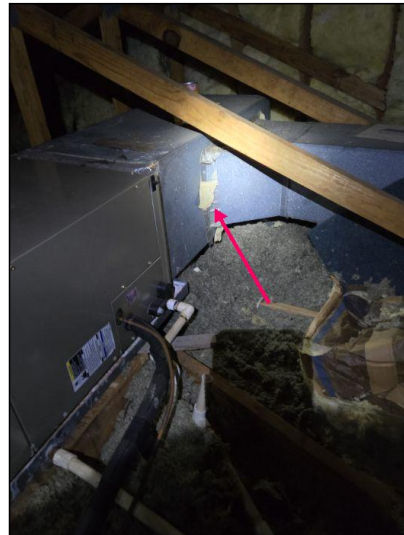
Wrapping is torn in areas.

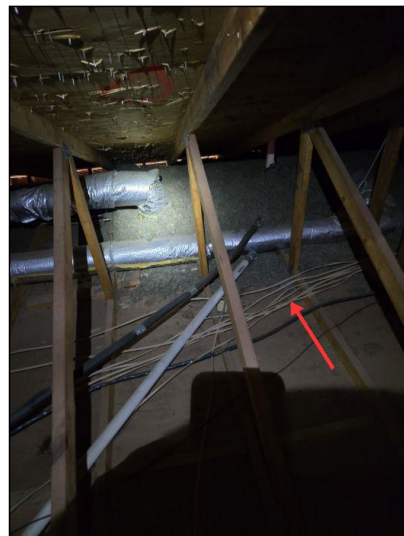
All wiring should be properly secured to the framing.

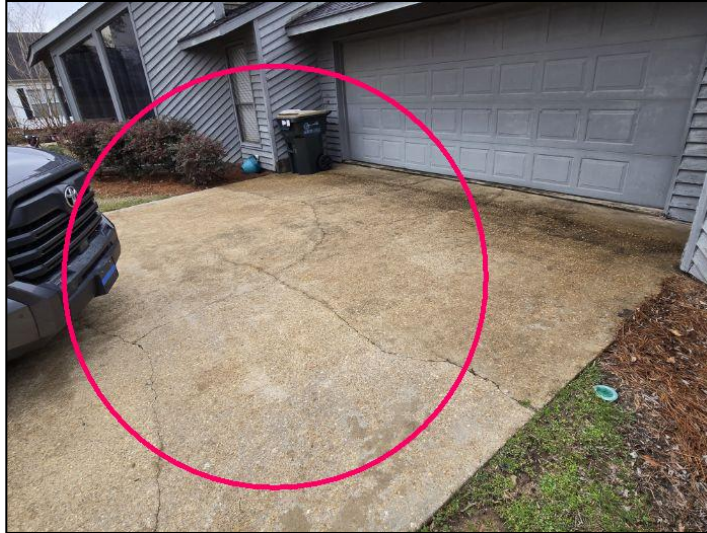
Small cracking.

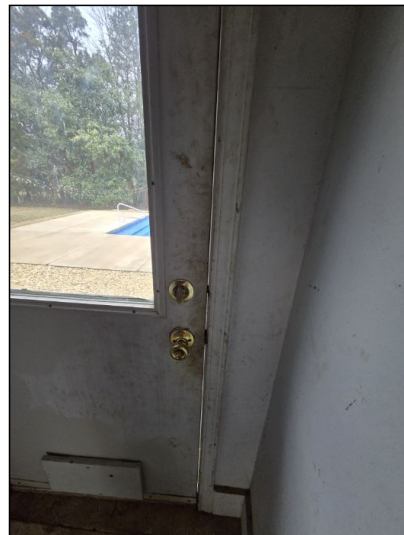
Doors do not seal well. this can be an energy drain.

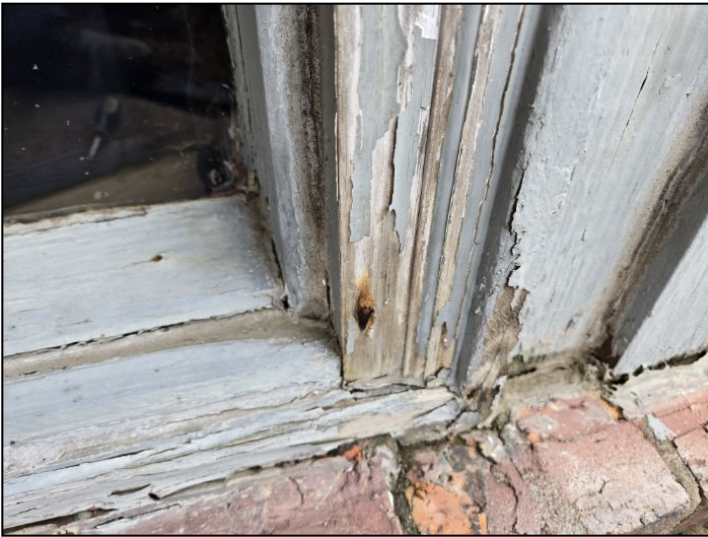
Deteriorated frame(s) at window(s)

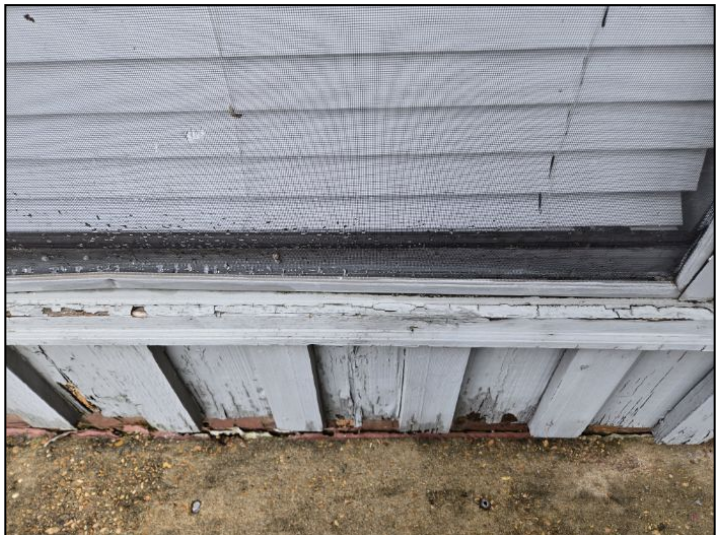
Deteriorated frame(s) at window(s)

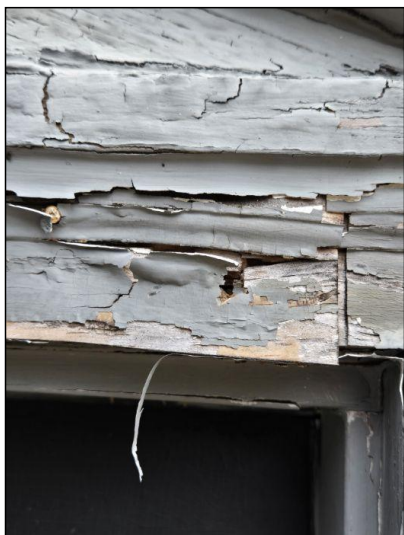
Deteriorated frame(s) at window(s)

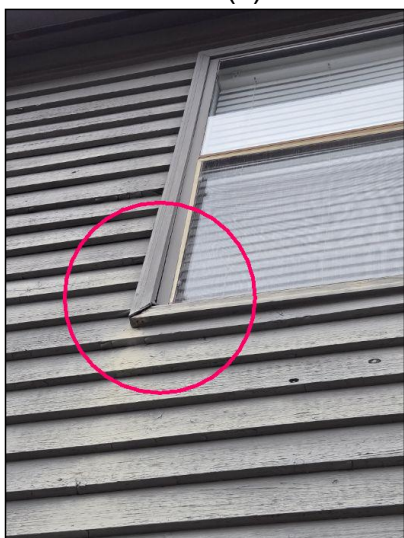
Deteriorated frame(s) at window(s)

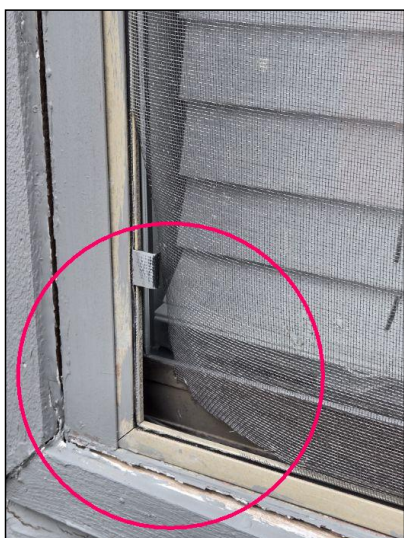
Some window screens damaged.

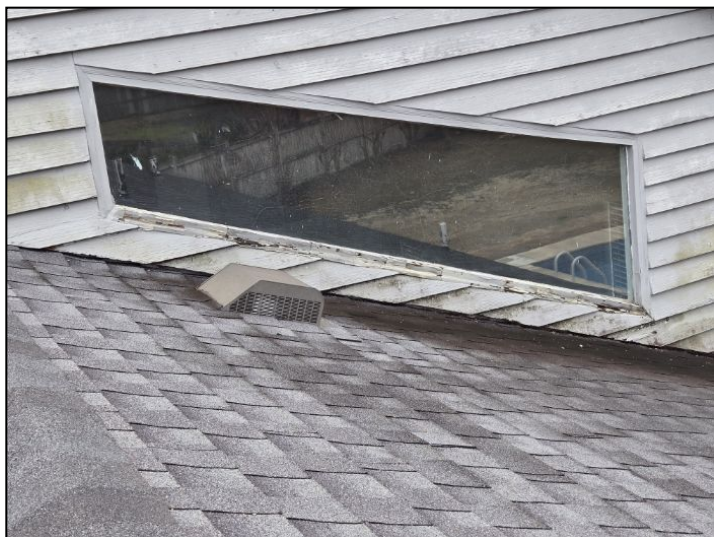
Deteriorated frame(s) at window(s)

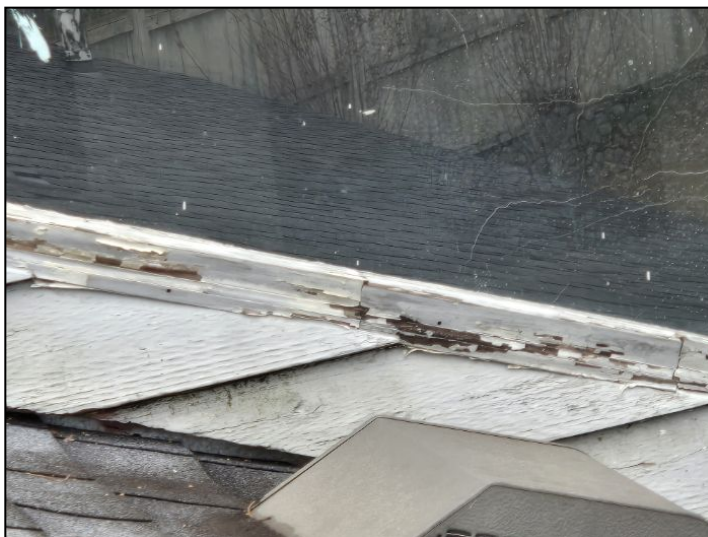
Deteriorated frame(s) at window(s)

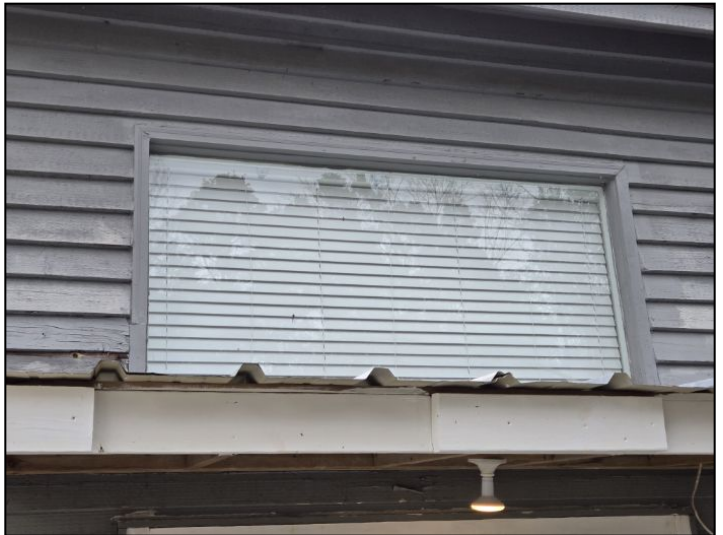
Peeling paint observed, suggest scraping and painting as necessary.

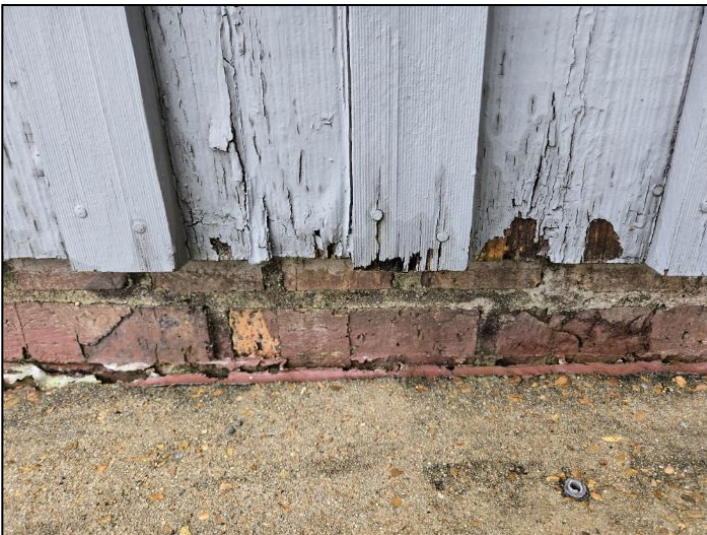
Some wood deterioration noted. Have repaired as necessary.

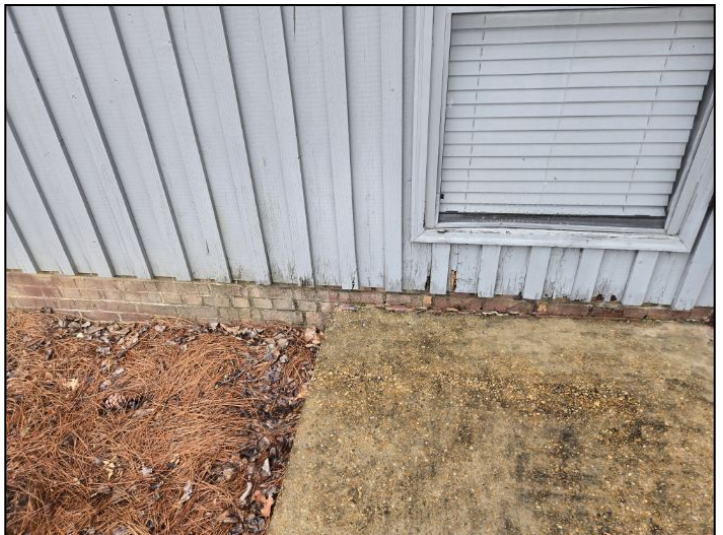
Some wood deterioration noted. Have repaired as necessary.

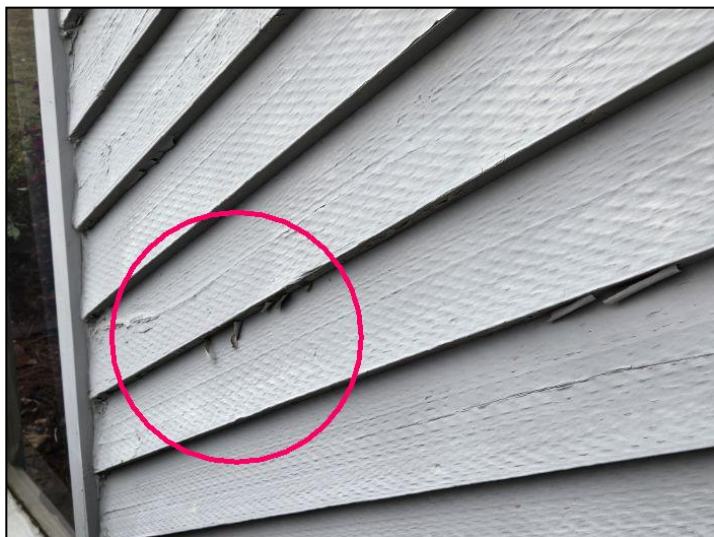
Some areas need priming and repainting.

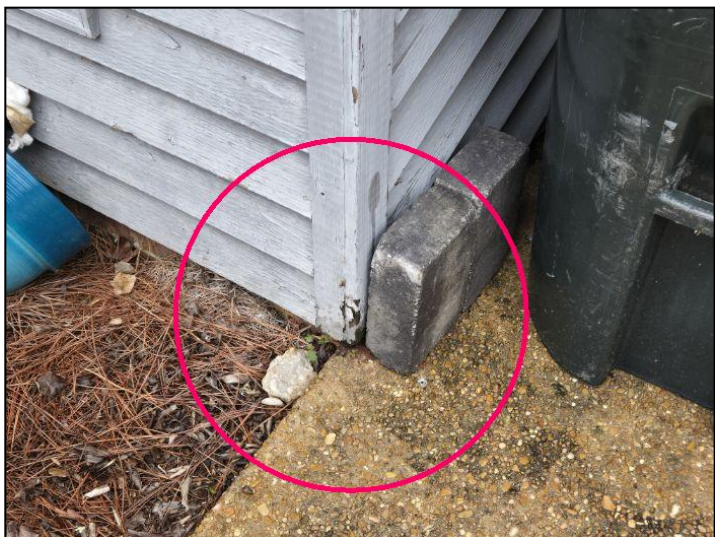
Some wood deterioration noted. Have repaired as necessary.

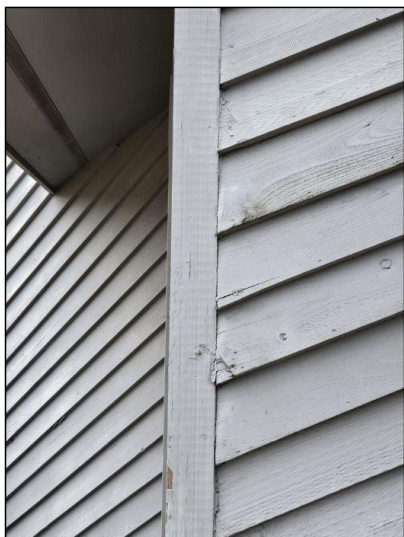
Caulk and seal all gaps, cracks and openings.

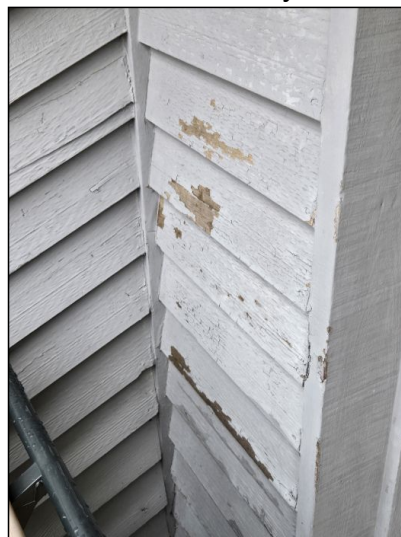
Some areas need priming and repainting.

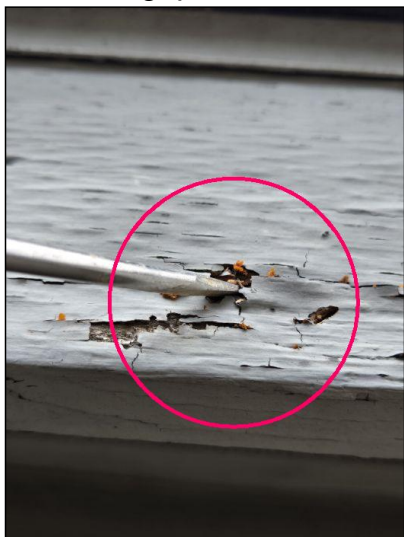
Some wood deterioration noted. Have repaired as necessary.

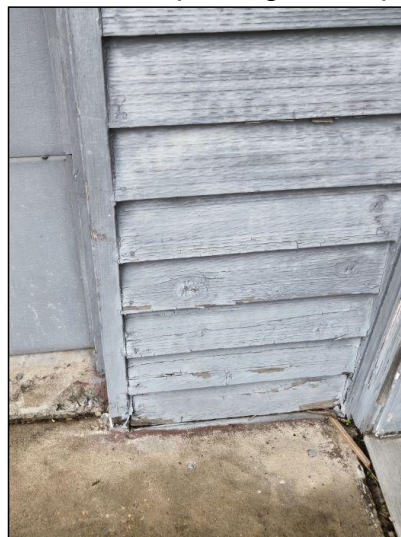
Some areas need priming and repainting.

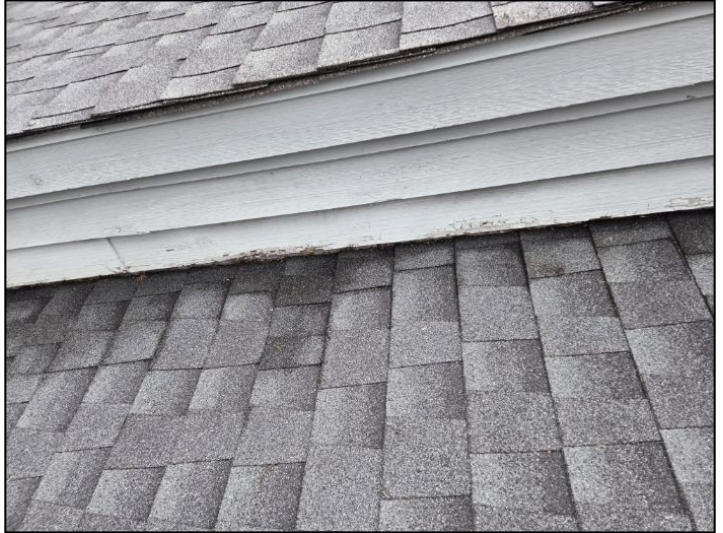
Some wood deterioration noted. Have repaired as necessary.

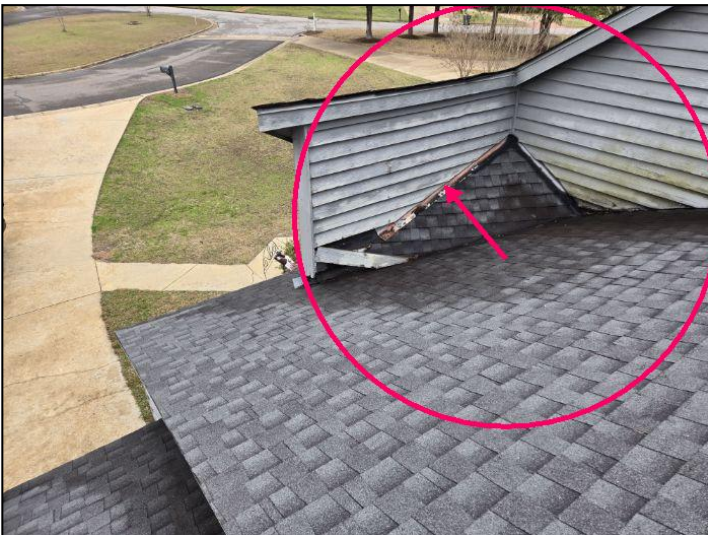
Some wood deterioration noted. Have repaired as necessary.

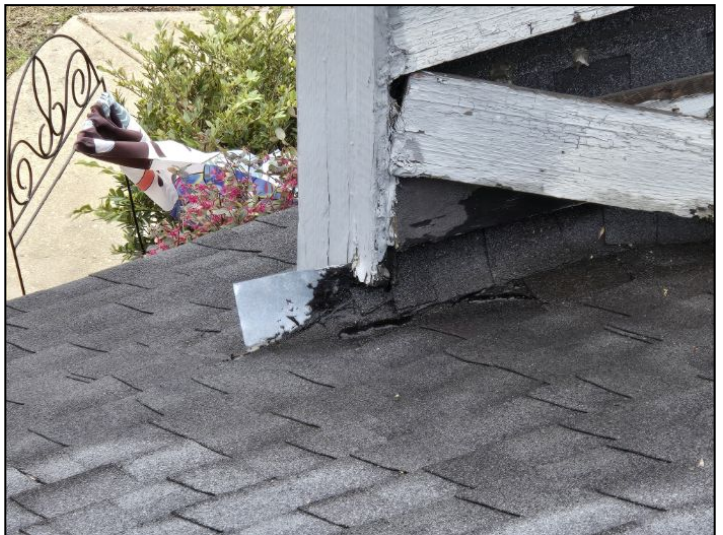
Some wood deterioration noted. Have repaired as necessary.

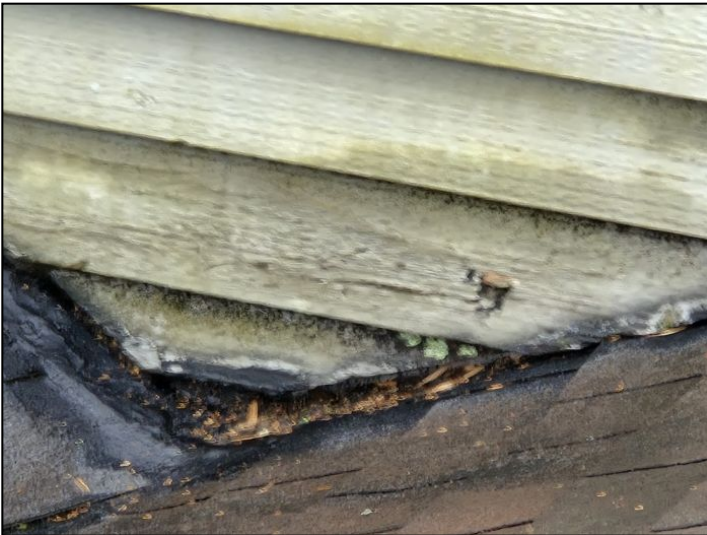
Some wood deterioration noted. Have repaired as necessary.

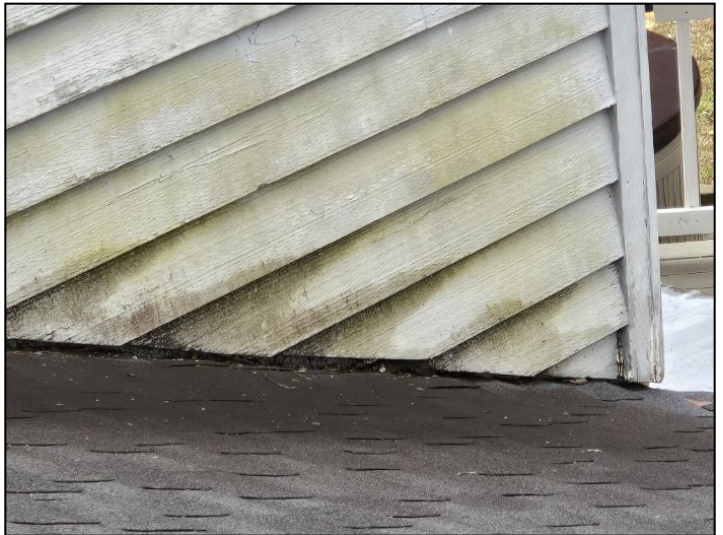
Some wood deterioration noted. Have repaired as necessary.

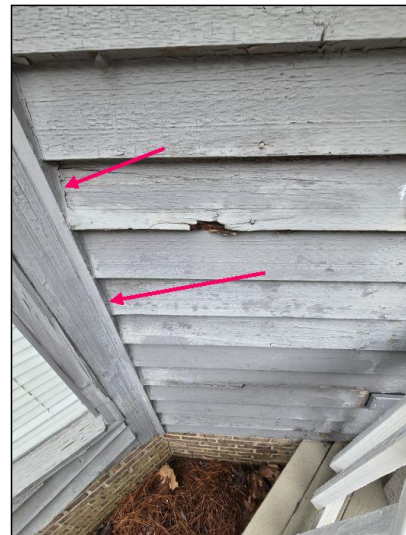
Caulk and seal all gaps, cracks and openings.

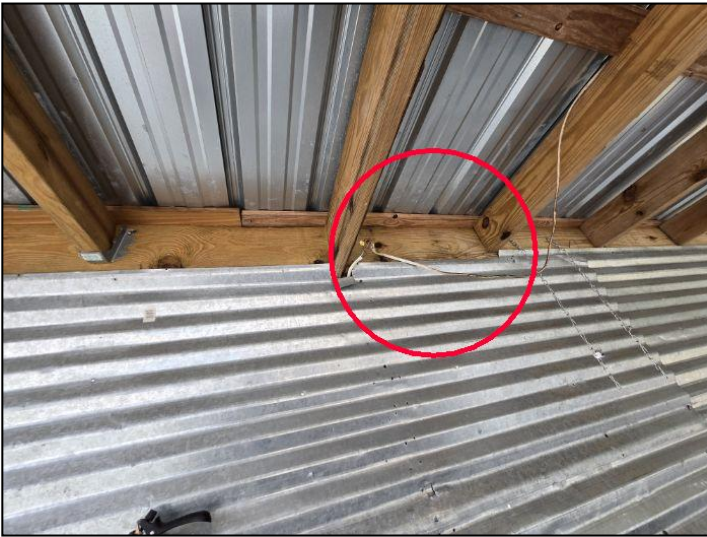
Water damage.

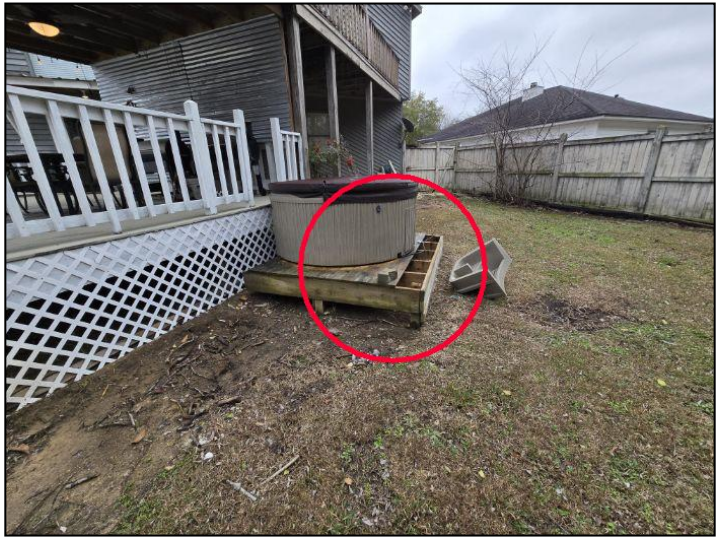
Hot tub decking falling apart, and has water damage.

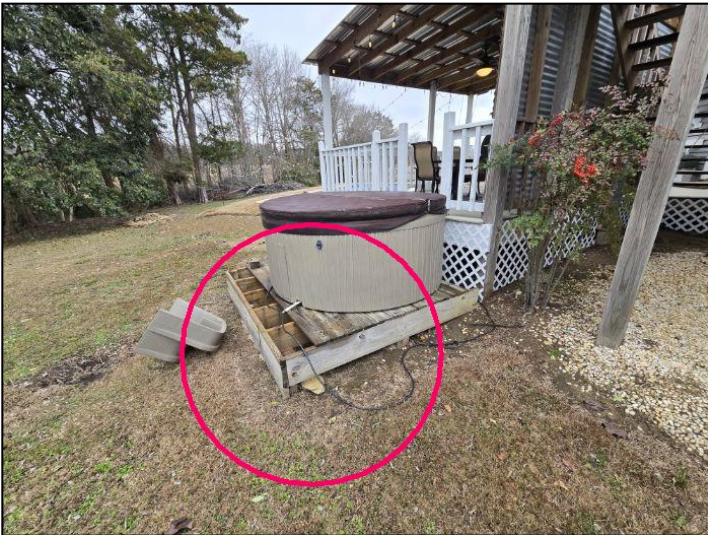
Hot tub decking falling apart, and has water damage.

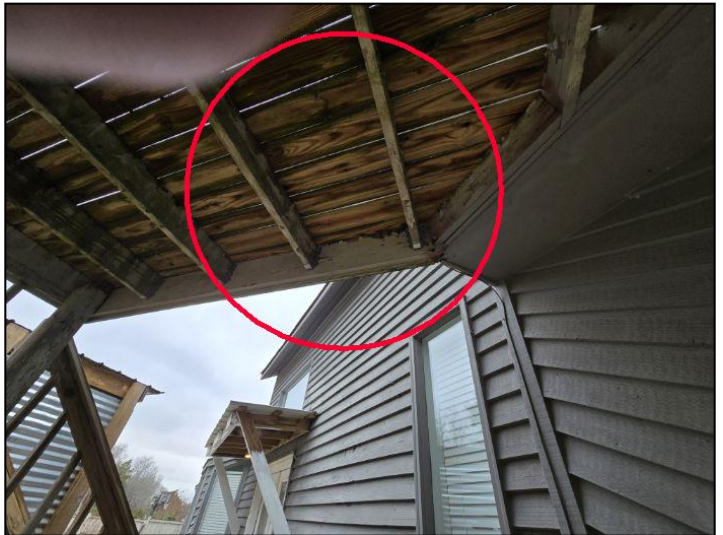
Severe water damage to decking. Should have a professional check before use.

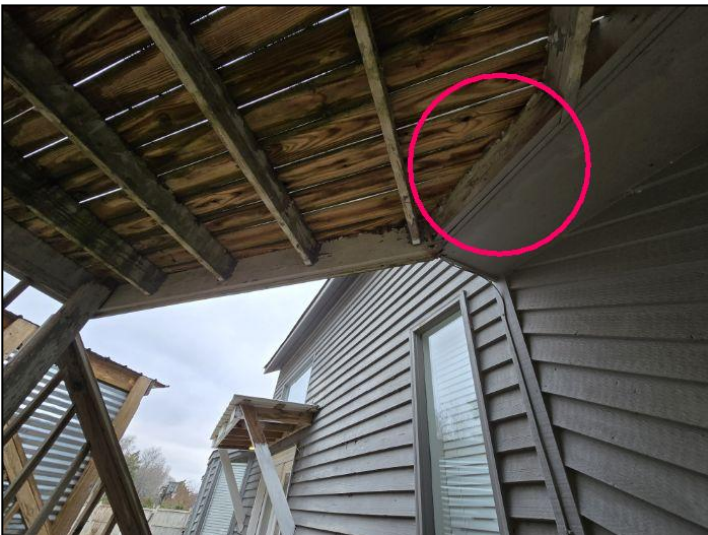
Deck not properly mounted to home.

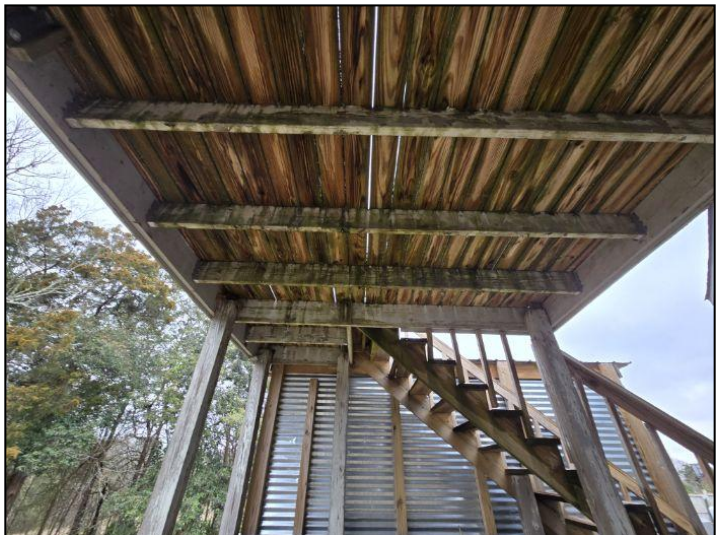
Possible mold growing under deck from severe water damage.

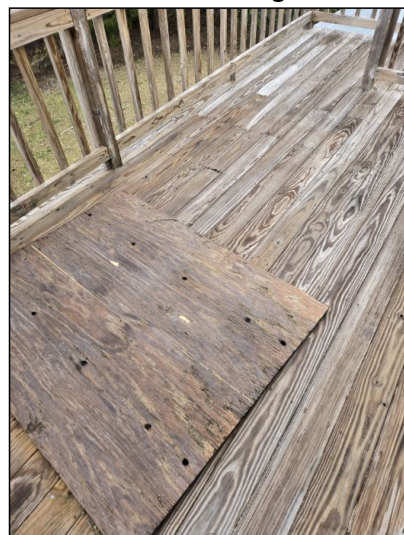
Possible severe water damage. Should have a professional look at it.
