# **PROPERTY INSPECTION REPORT FOR 2004 Marengo Dr**

**Bama Home Inspections llc**

**2004 Marengo Dr**

**Date of Inspection: 2/19/2025**

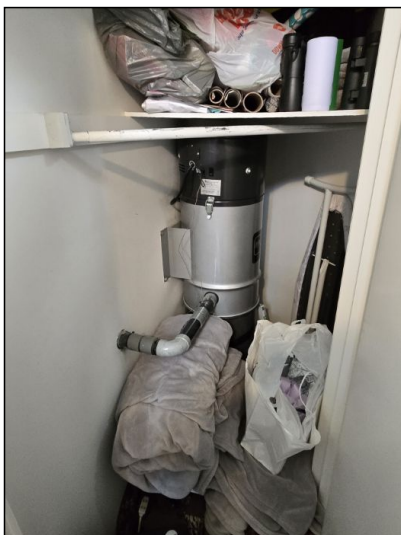
Central vacuum. Not checked due to blocked by owners belongings.

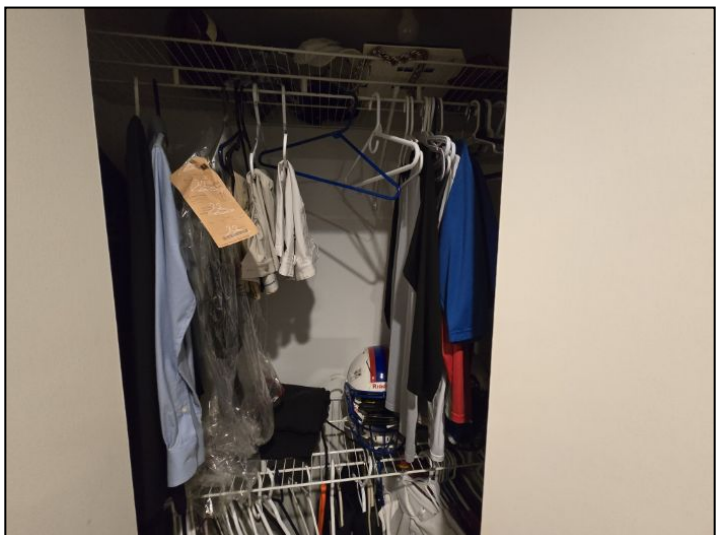
Left front bedroom closet light not working.

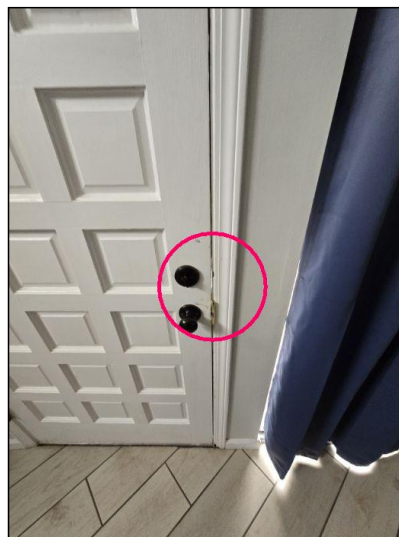
All exterior doors needs the seals replaced.

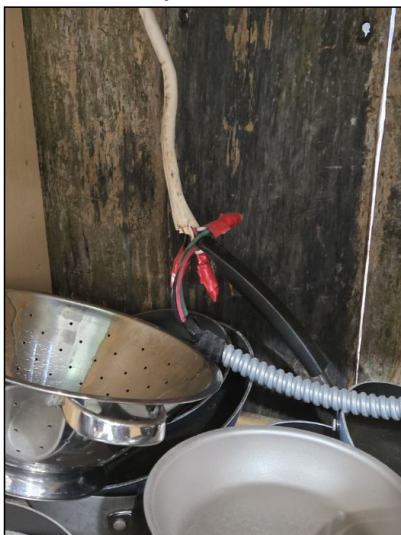
All electrical connections should be located in a junction box.

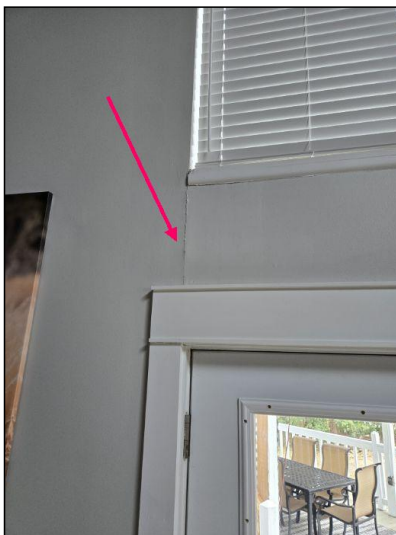
Settlement cracking. Should have a professional look at and repair.

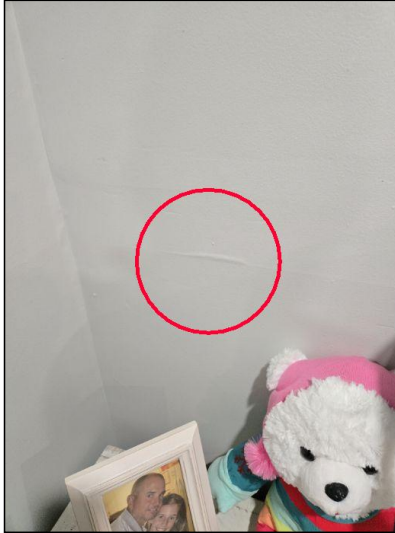
Paint bubble in left rear bedroom. Possibly from water.

- There is evidence of moisture entering structure. We recommend contacting a contractor experienced in exterior systems to evaluate the area and suggest repair options.

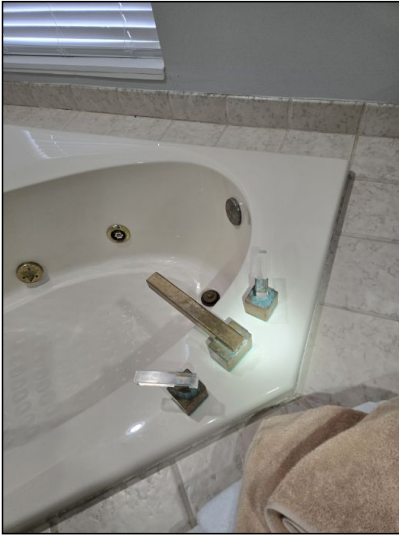
Hot water did not warm up. Fixtures are starting to corrode.

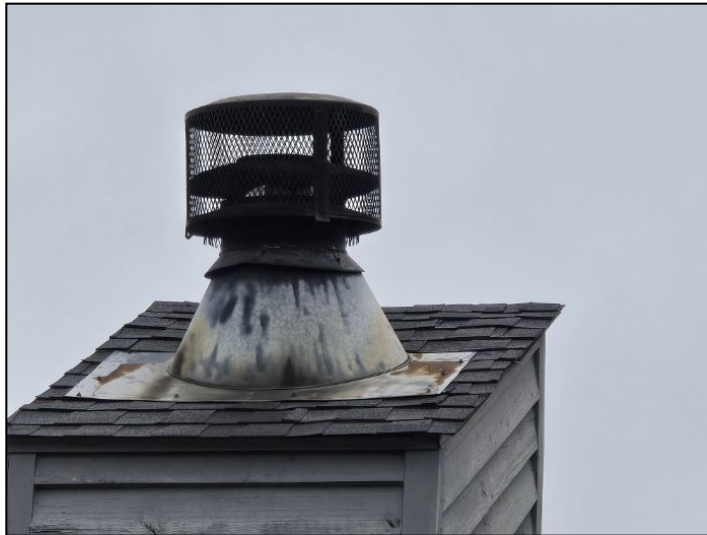
Chimney cap not properly sealed or covered.

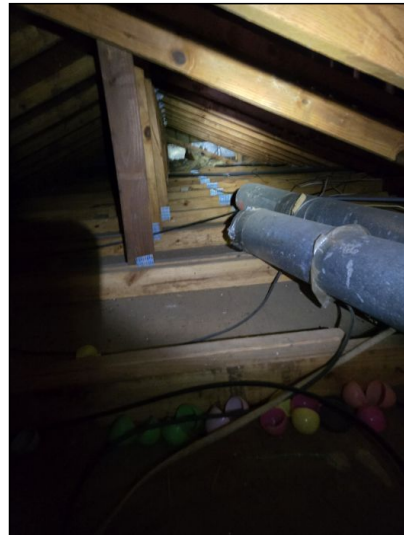
Insulation is sparse in some areas.

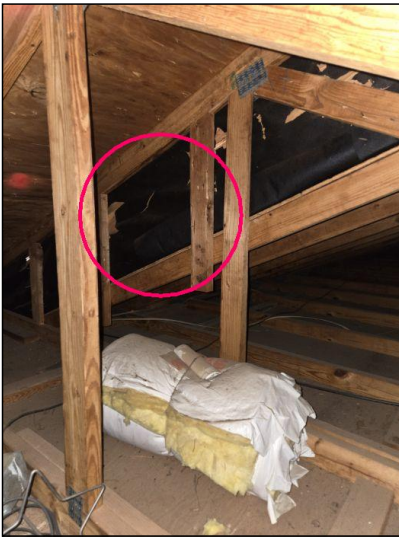
Wall paper torn in several spots. Can see daylight through wall.

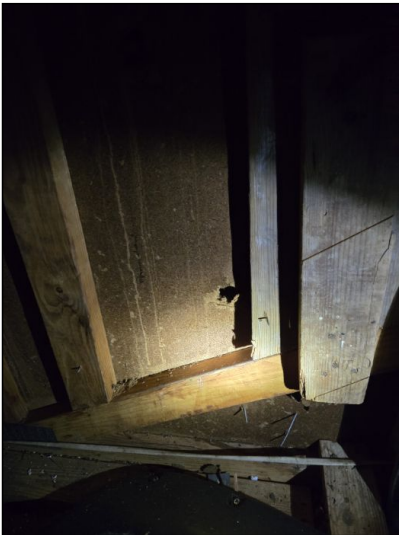
All holes to the exterior should be covered.

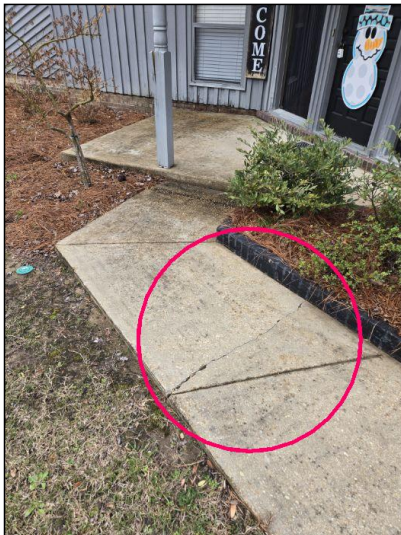
Small cracks in walkway. Should be monitored.

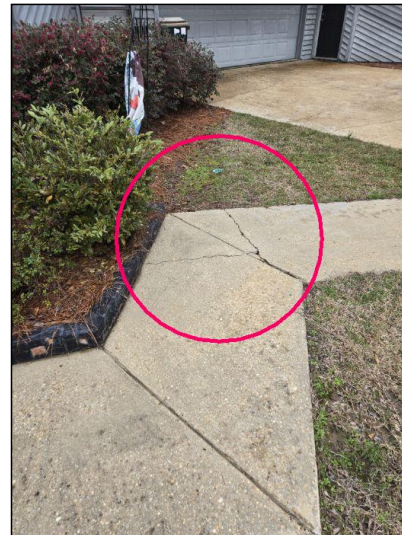
Small cracks in walkway. Should be monitored.

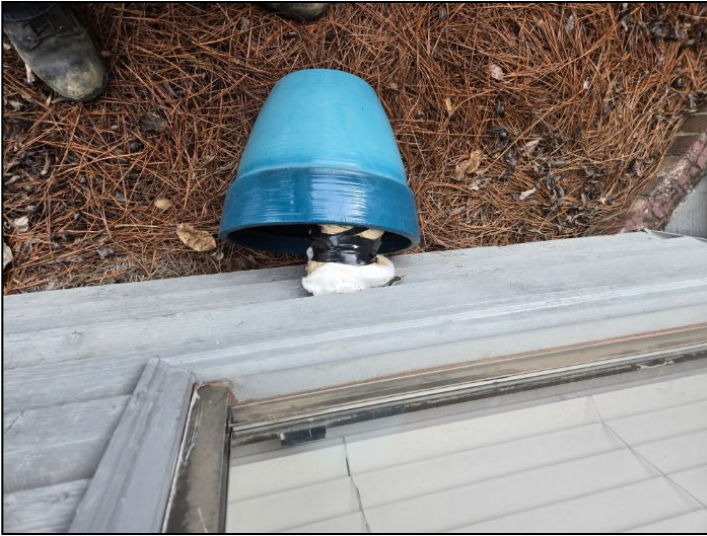
Located front of house. Unable to check due to covering. Located at front of house.

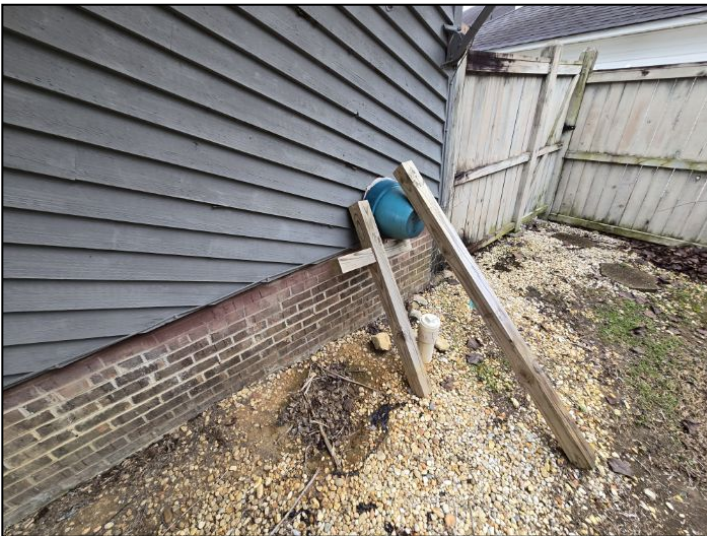
Located at rear of house. Unable to check due to winter coverings.

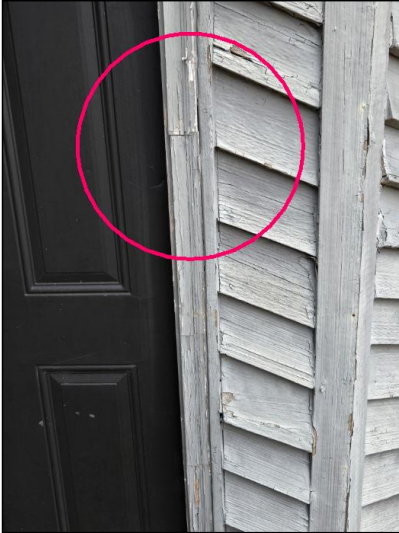
Wood deterioration observed. Suggest repairs/replacement as needed.

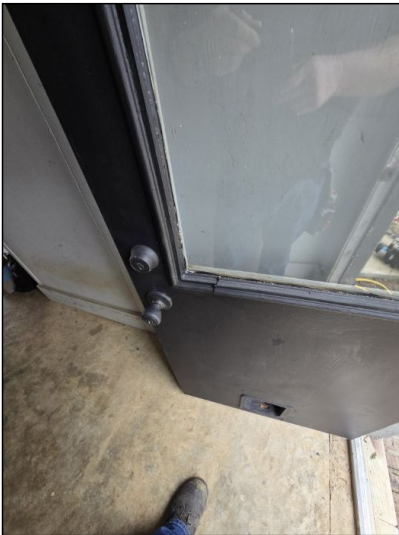
Wood deterioration observed. Suggest repairs/replacement as needed.

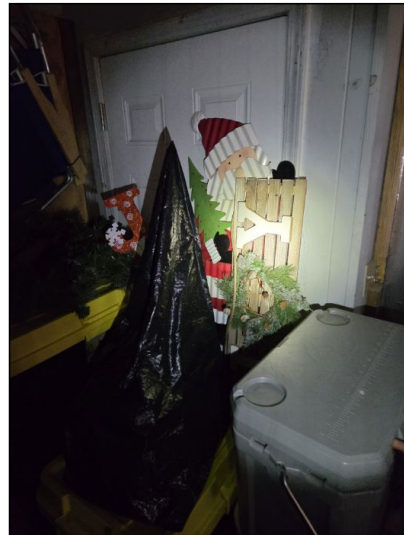
Exterior front garage door blocked by owners personal property.

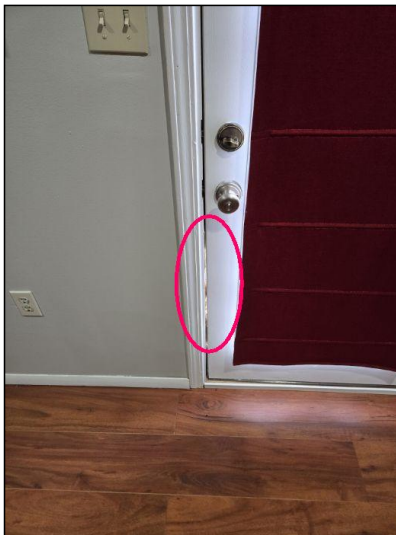
Doors do not seal well. this can be an energy drain.

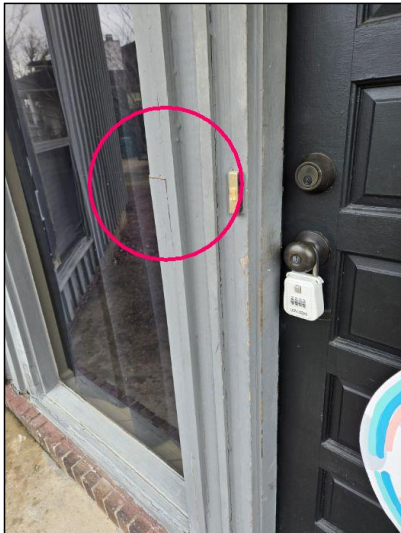
Frame separating from glass

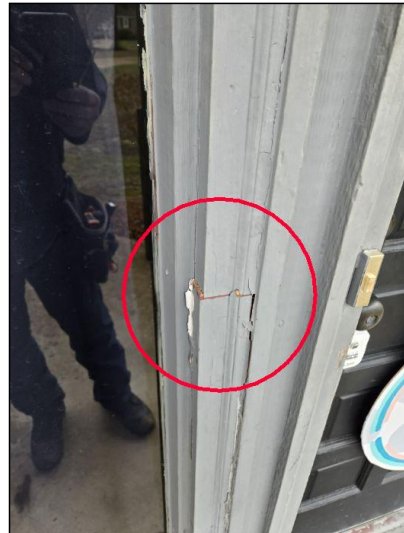
Frame separating from glass

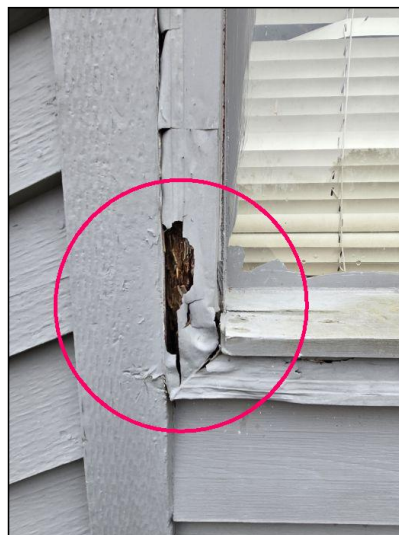
Deteriorated frame(s) at window(s)

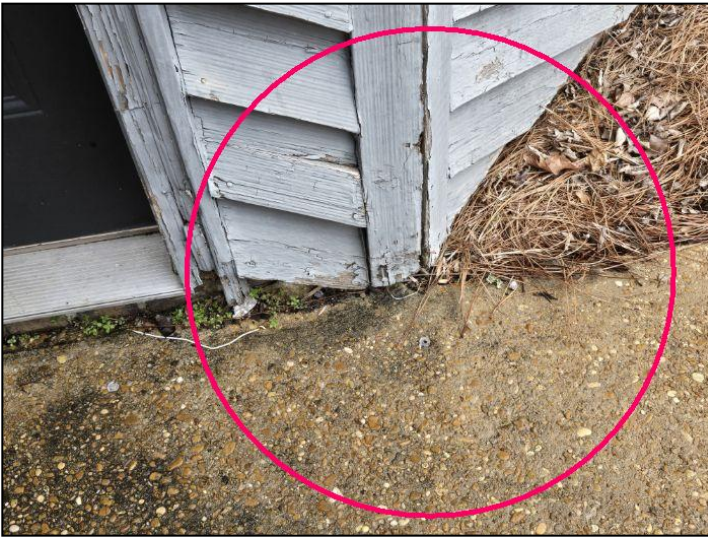
Siding in contact with ground.

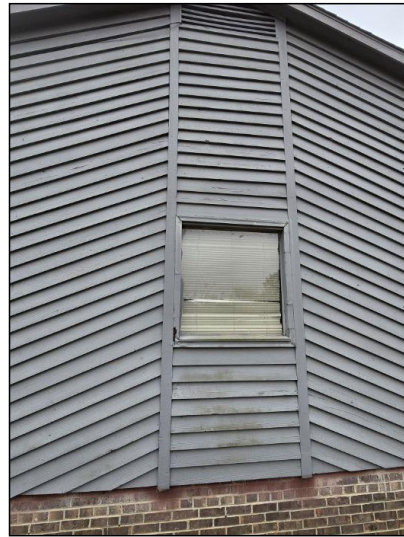
Some areas need priming and repainting.

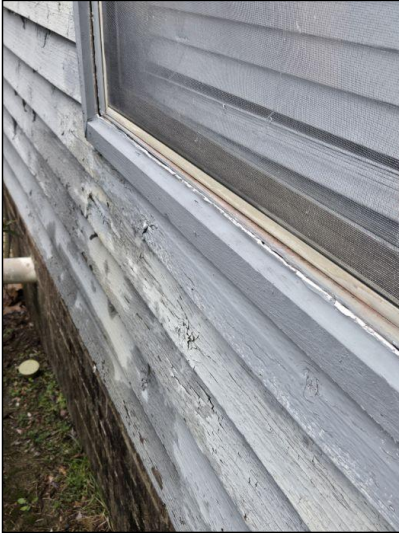
Some wood deterioration noted. Have repaired as necessary.

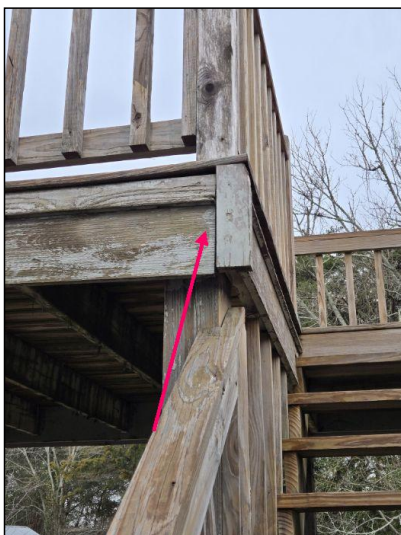
Joists starting to pull away from each other.
