# **PROPERTY INSPECTION REPORT FOR 2004 Marengo Dr**

**Bama Home Inspections llc**

**2004 Marengo Dr**

**Date of Inspection: 2/19/2025**

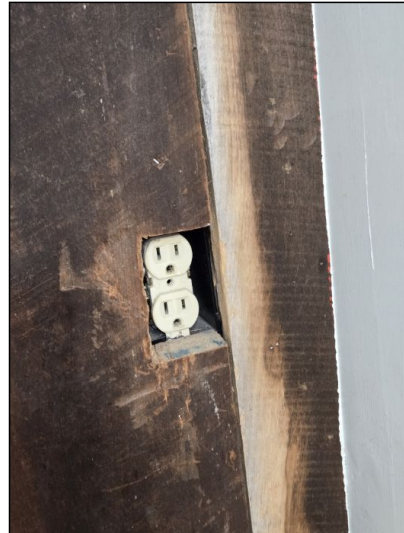
Missing cover.

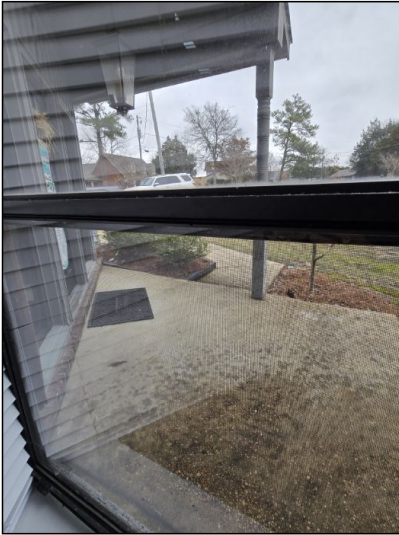
Windows would not open during the inspection.

In the inspectors opinion the windows/frames are near the end of their useful life.

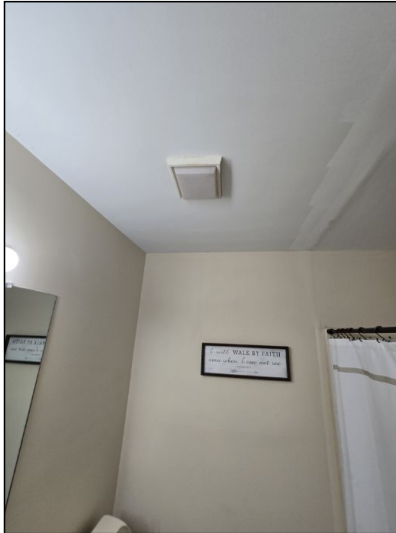
Light on exhaust fan not working. Very low air flow from vent fan.

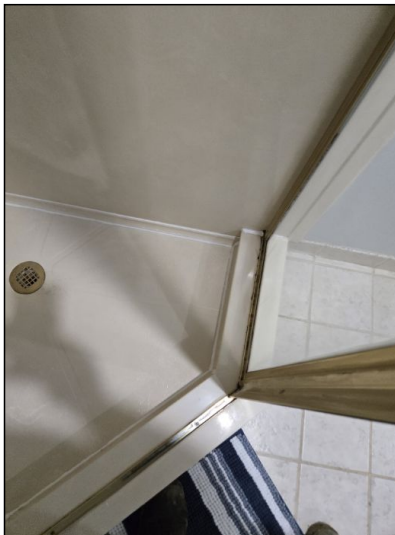
Master bathroom shower and tub need new chaulking, and possible mold present.

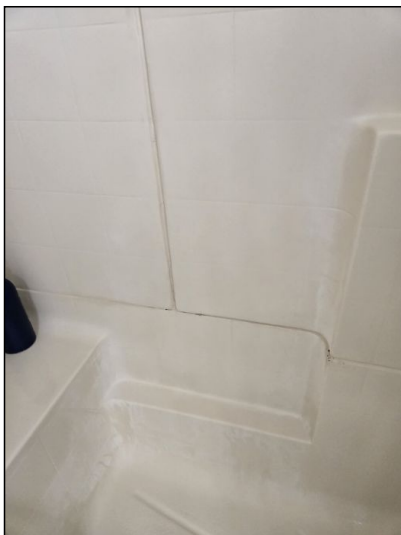
Suggest have checked by professional. Possible mold noted on caulk.

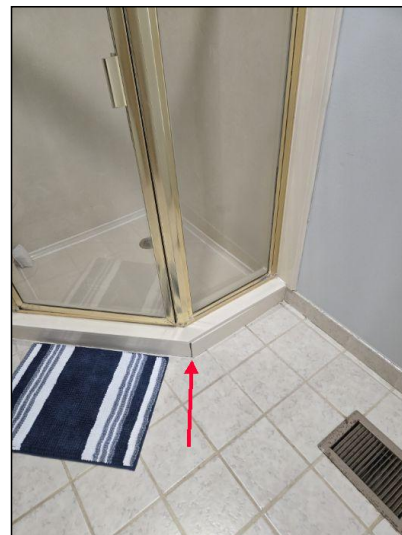
Caulking needed around perimeter.

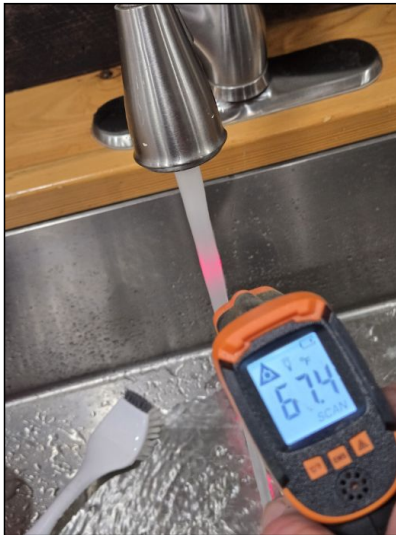
Hot water needs adjustment. This is the hottest I could get the hot water.

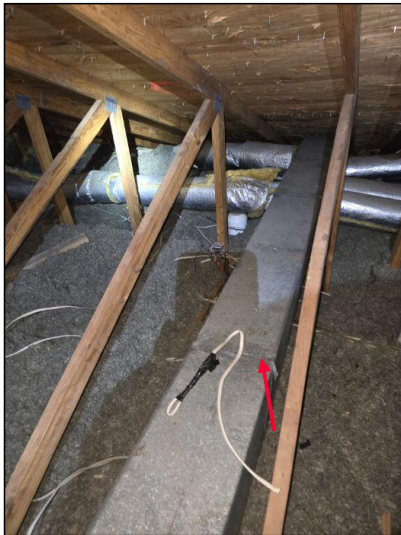
Recommend taping.

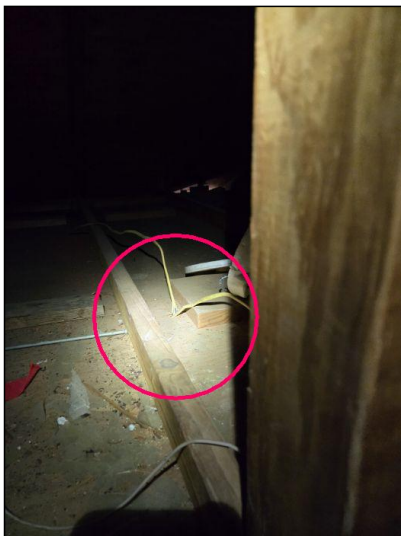
Connections made outside of a Junction Box, which is a potential shock or electrocution hazard.

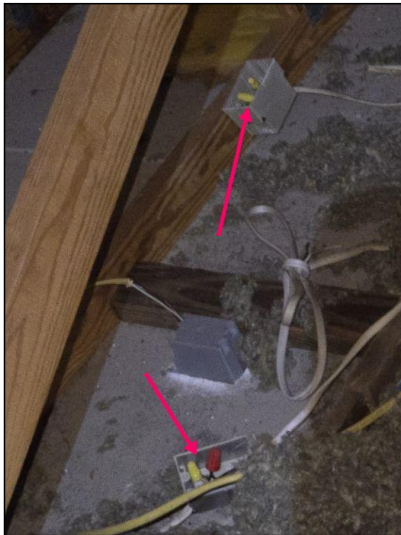
Junction boxes should be secured to framing.

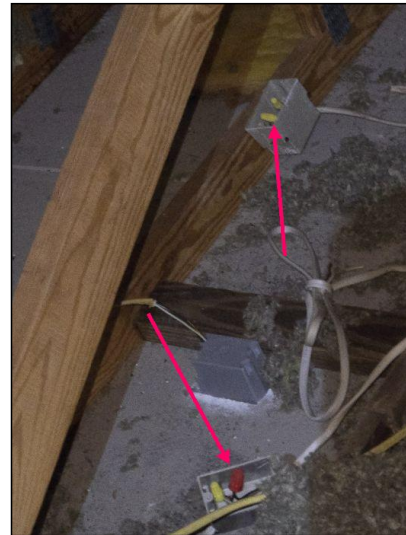
Exposed junction boxes need to have a cover.

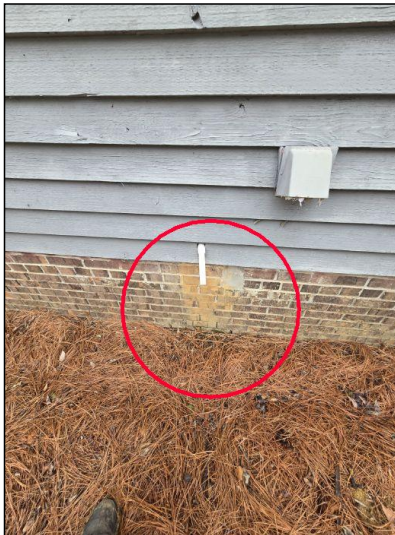
Water damage.

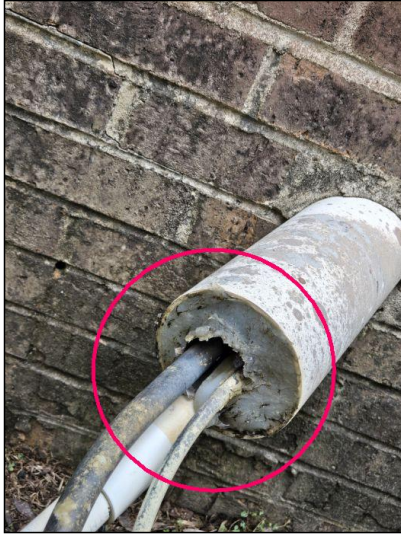
Hole should be sealed to prevent critters and insects from entering home.

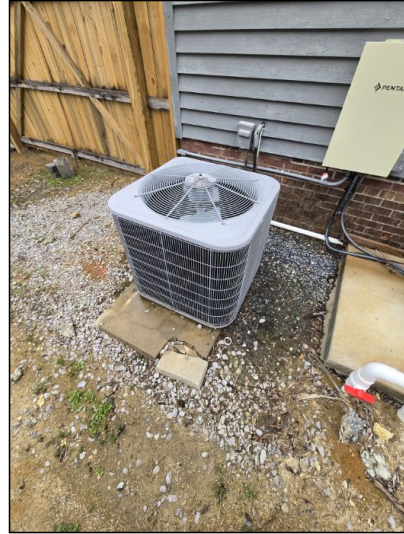
Good condition. Should be checked by a licensed HVAC contractor.

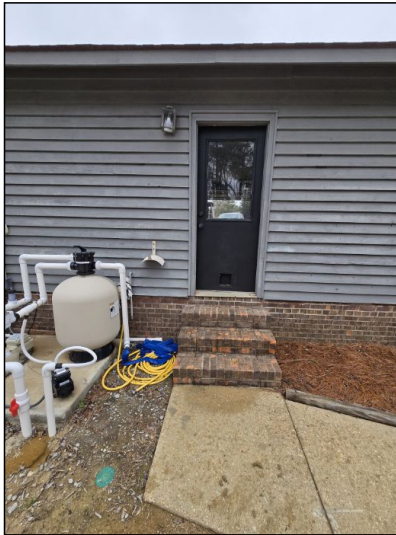
3 steps or more should have a handrail.

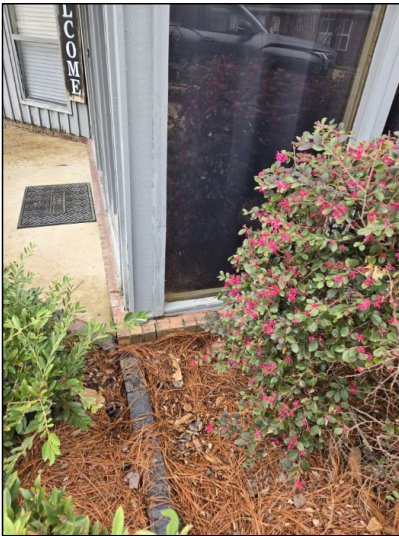
Bushes to close to house.

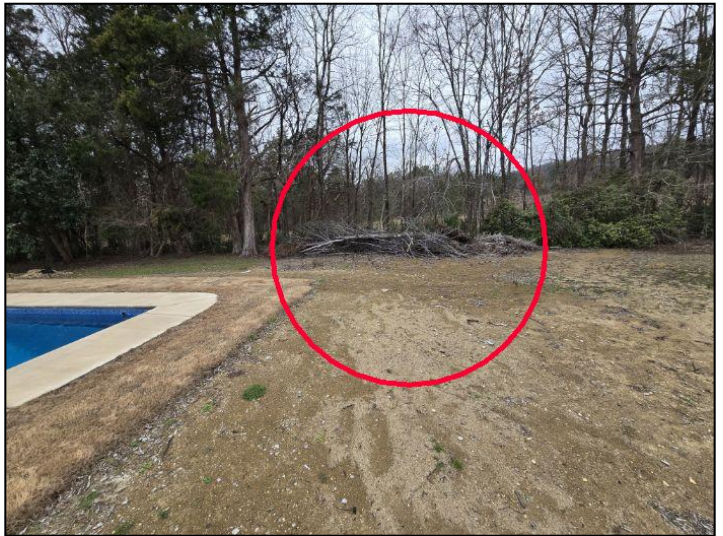
Brush pile should be removed. Can attract pests.

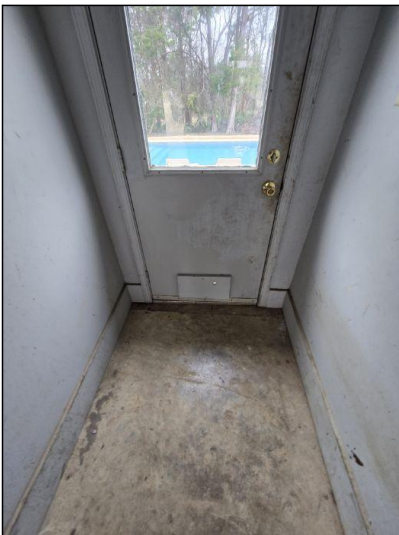
Peeling paint observed, suggest scraping and painting as necessary.

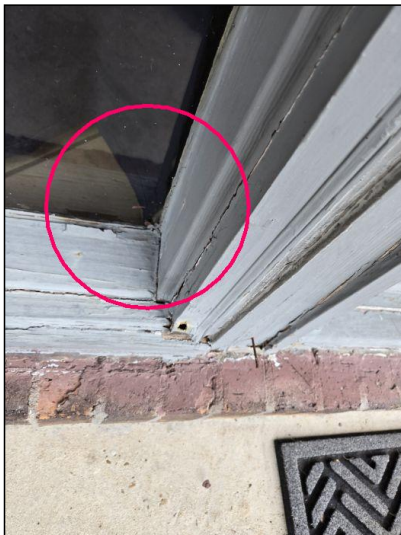
Suggest caulking around doors and windows as necessary.

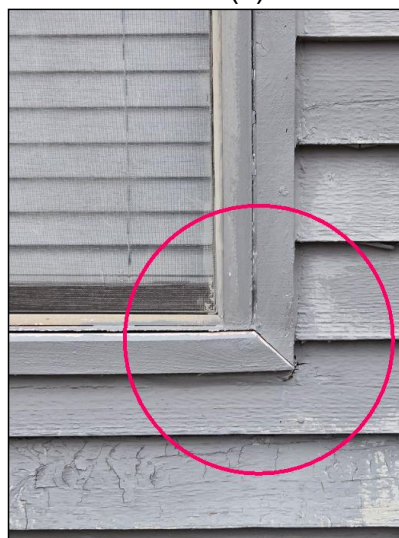
Peeling paint observed, suggest scraping and painting as necessary.

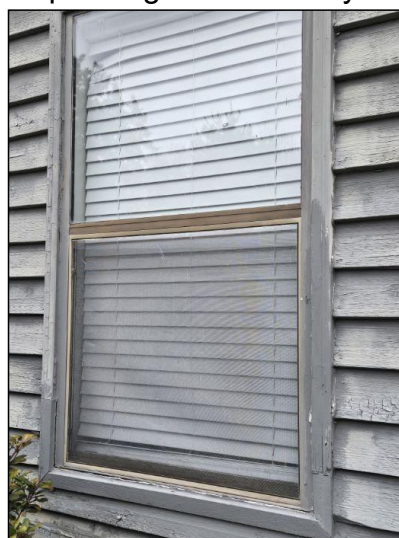
Peeling paint observed, suggest scraping and painting as necessary.

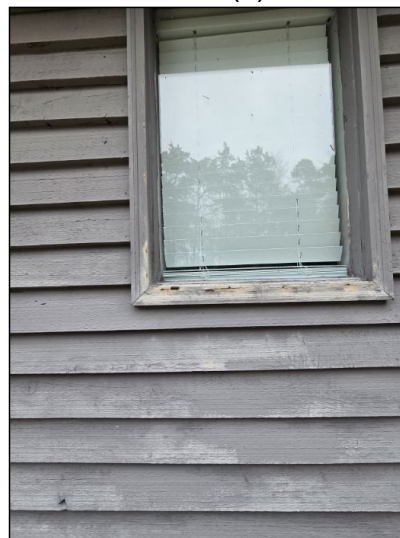
Deterioration of wooden frames noted. While basic maintenance may prolong the life of these window frames, replacement may be necessary at some point.

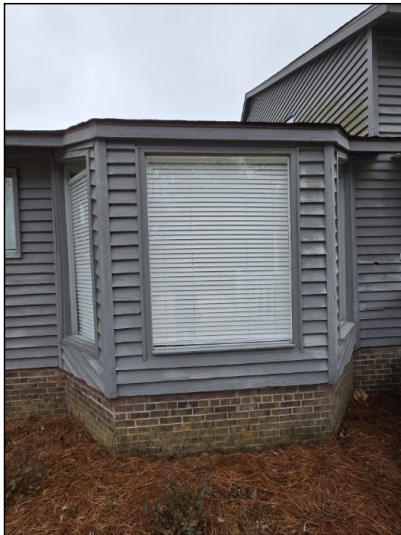
Peeling paint observed, suggest scraping and painting as necessary.

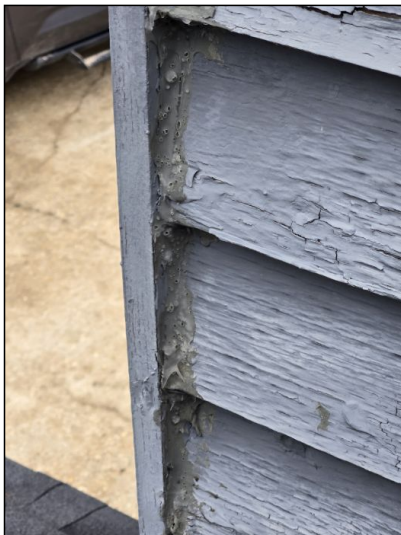
Caulk and seal all gaps, cracks and openings.

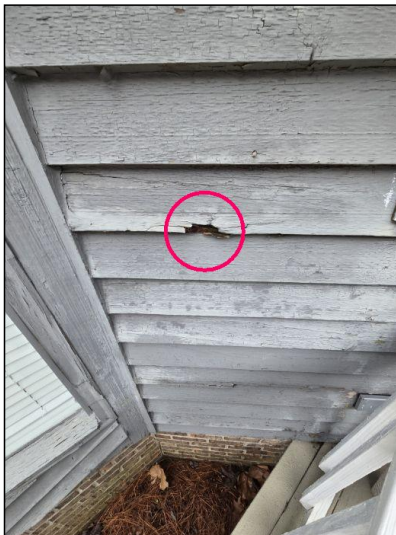
Some wood deterioration noted. Have repaired as necessary.

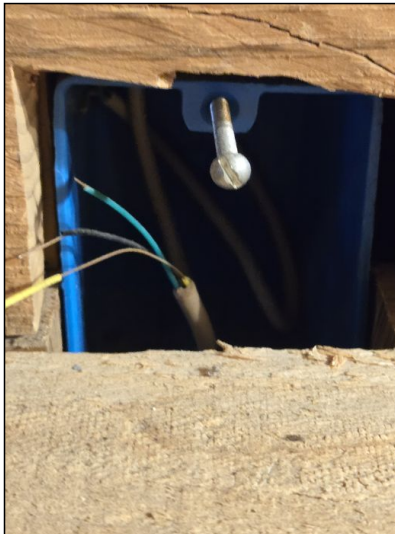
Exposed wiring.
